# REBUILDING I-95

# I-95 TANKER FIRE & BRIDGE COLLAPSE

Philadelphia, PA

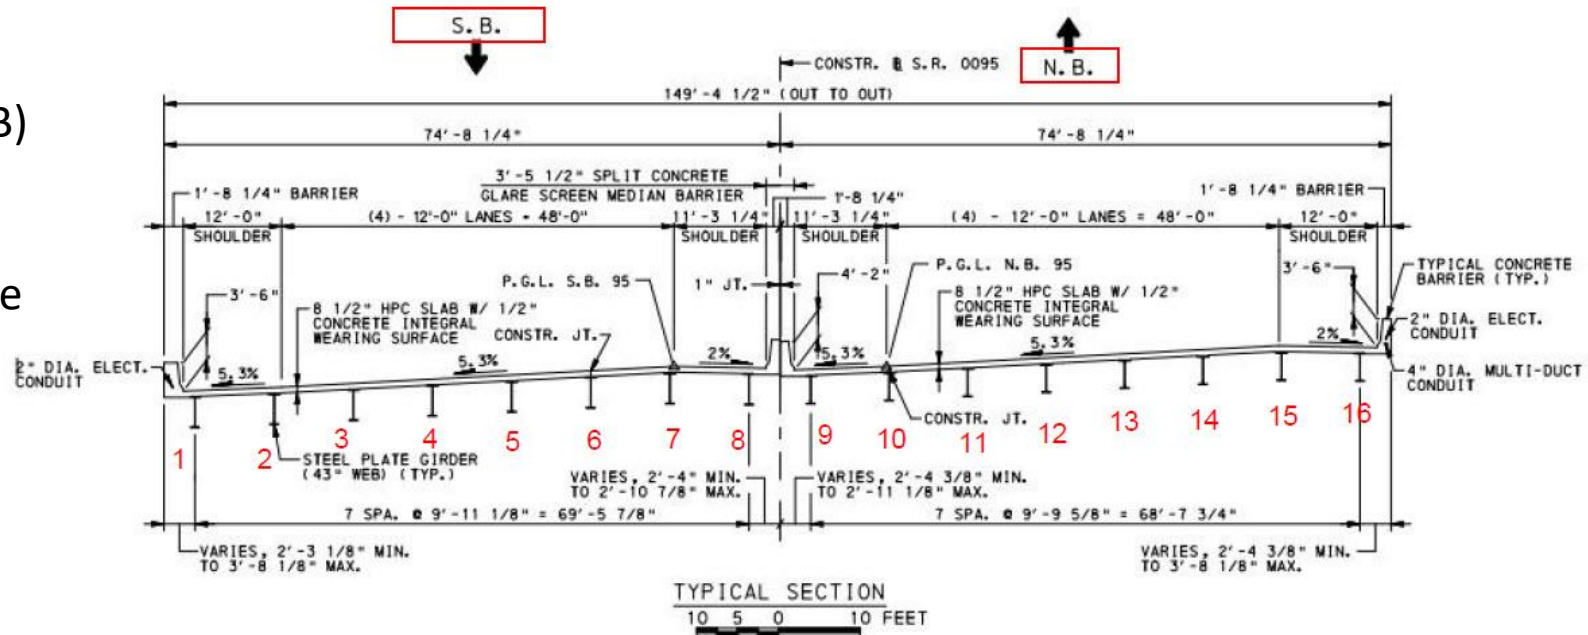
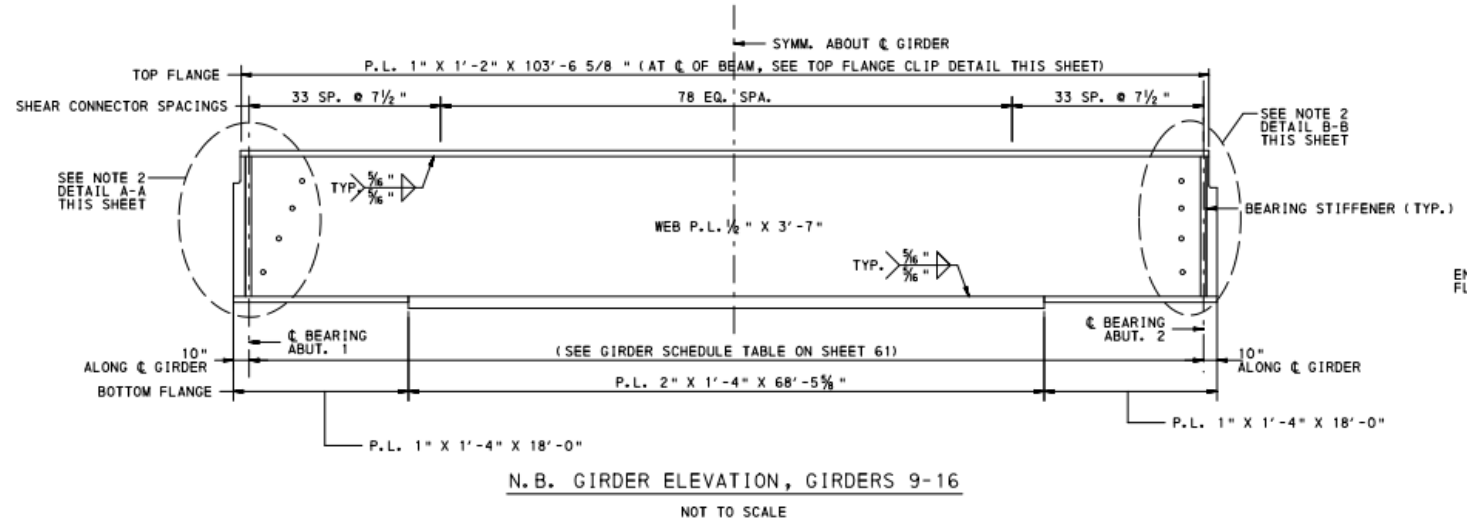
Question became what was the serviceability of SB portion (beams 1 to 8) of the structure?

**Each girder suffered distortion throughout.** The worst being beam 8 which was closest to the fuel source. East end of beam 8 bottom flange exhibited lateral and vertical distortion.

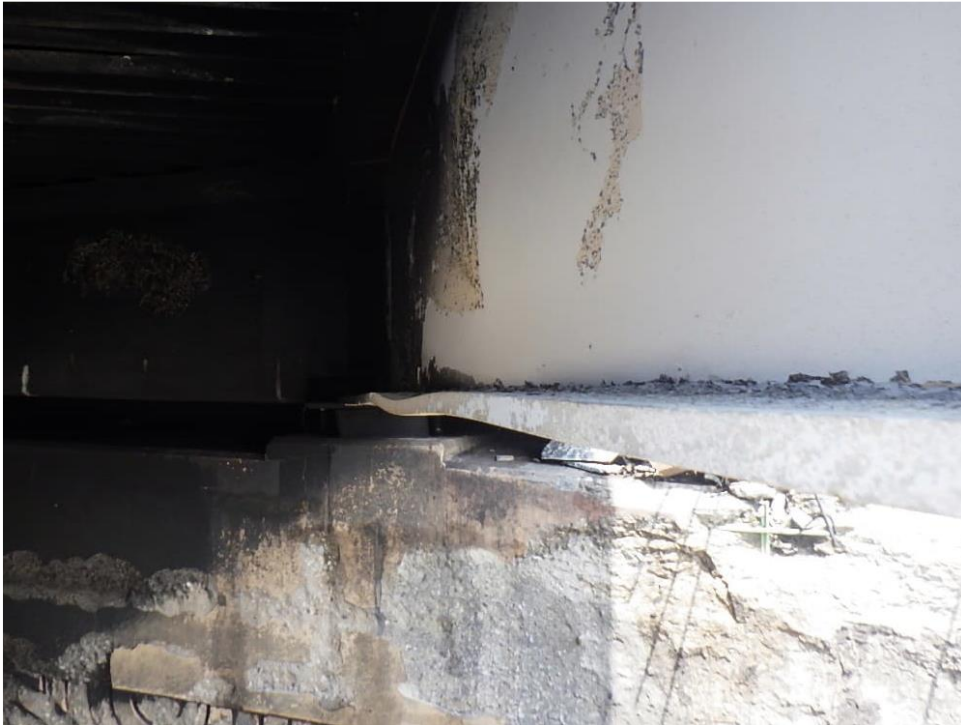
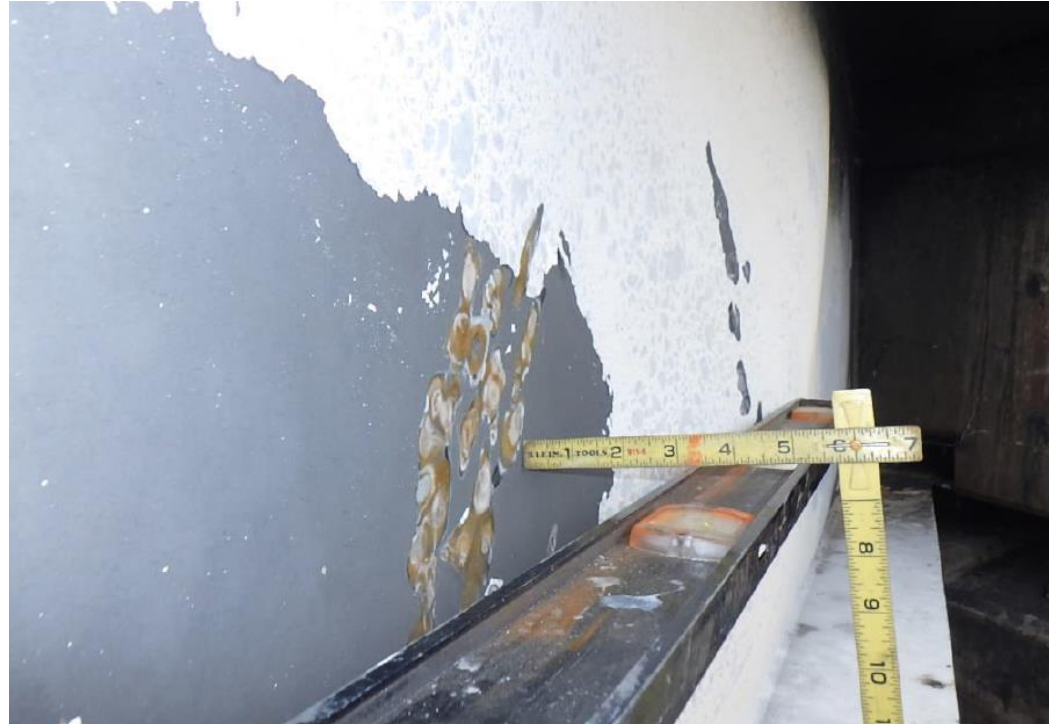
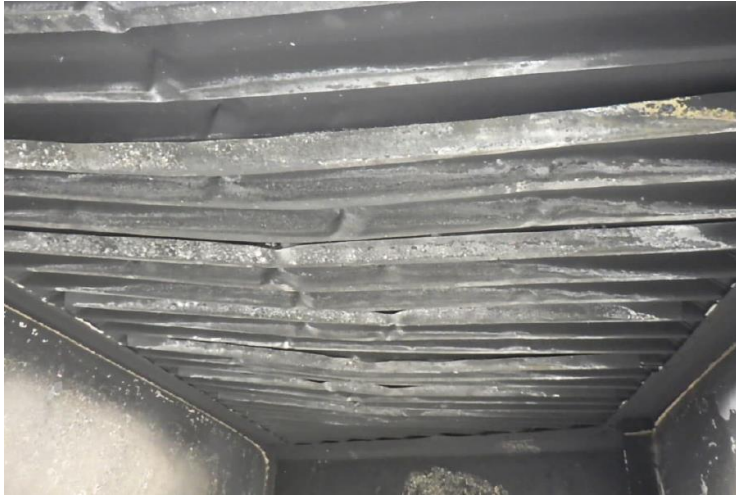
Steel deck SIP visibly distorted throughout all bays.

Intermediate cross frame diaphragms severe distortion throughout.

All elastomeric bearings at the far abutment had shifted to the left. Bearing not fully bearing on the pads.

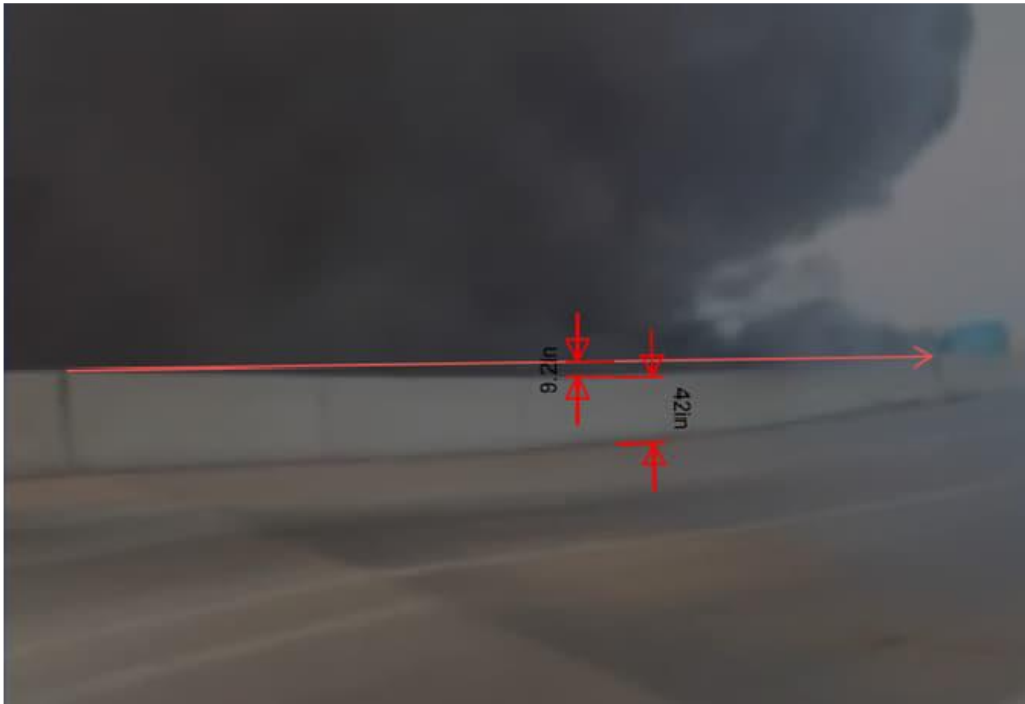
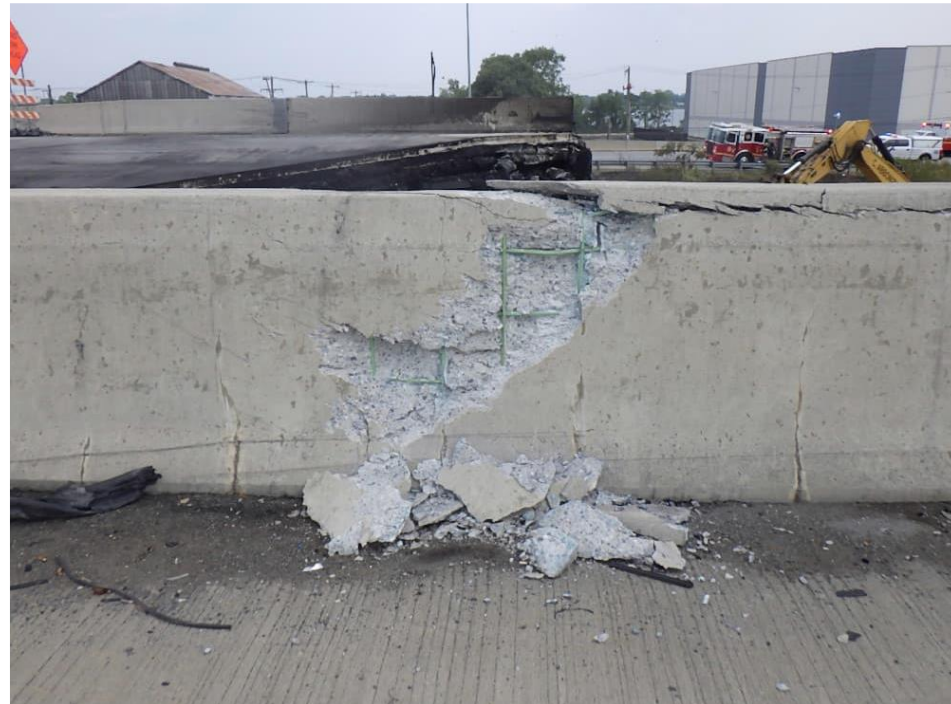
## SB showed significant elastic deformation

Videos shared on social media of public driving over the I-95 SB structure during the height of the fire showed a significant dip in the bridge deck. At time of inspection, the I-95 SB structure did not appear to exhibit this sag and rebounded back to near original profile.

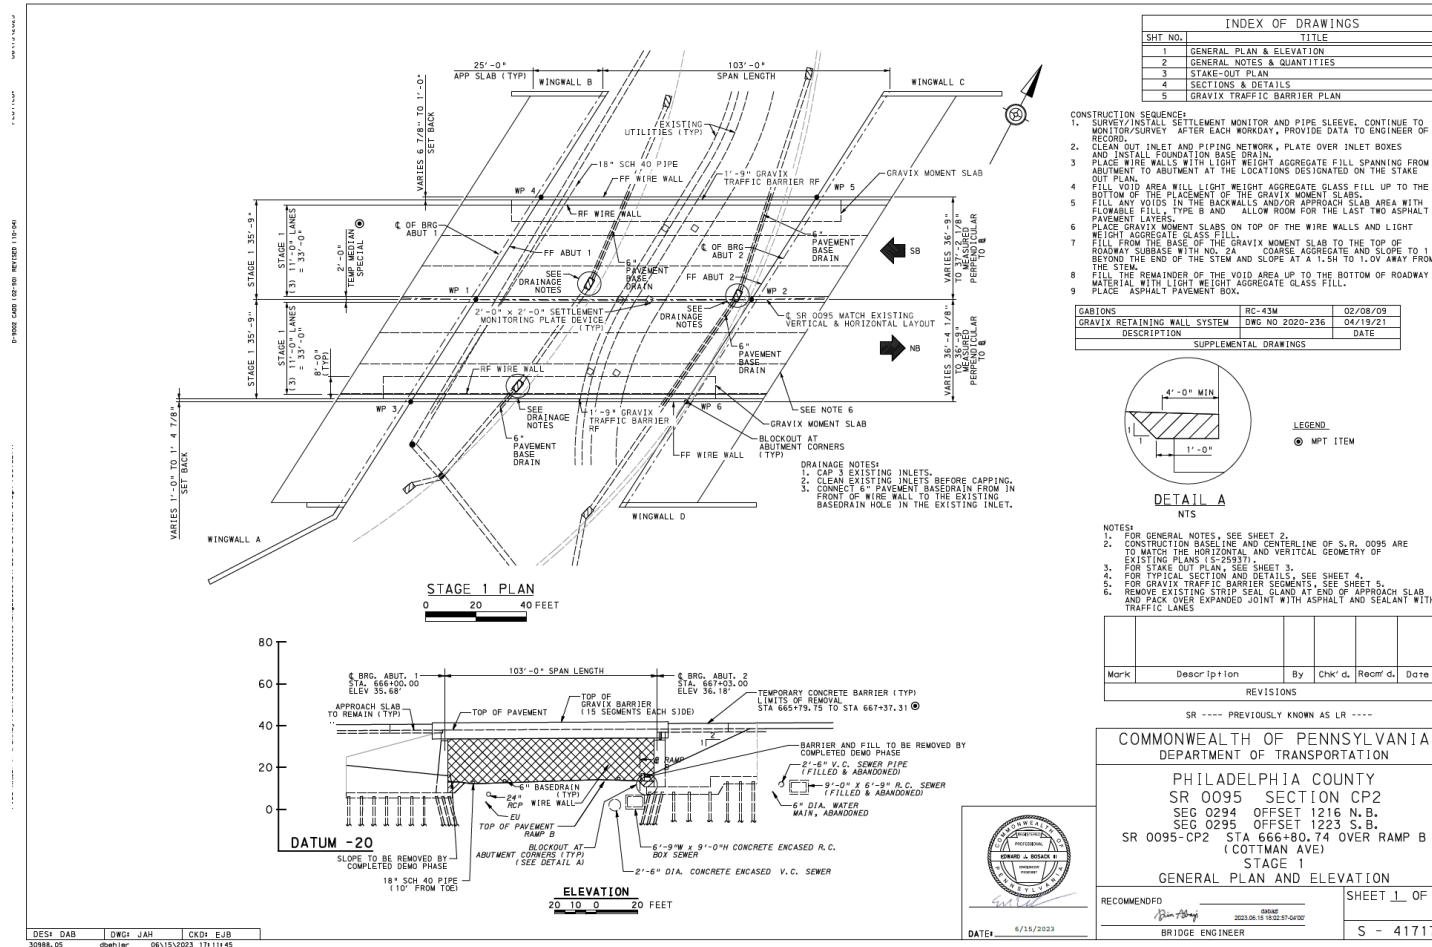
Type, Size and Location was provided to Aero Aggregate/Schnabel Engineering . They then provided shop drawings and external stability analysis for review and approval. Our permanent staging guided our decision making for the temporary solution.

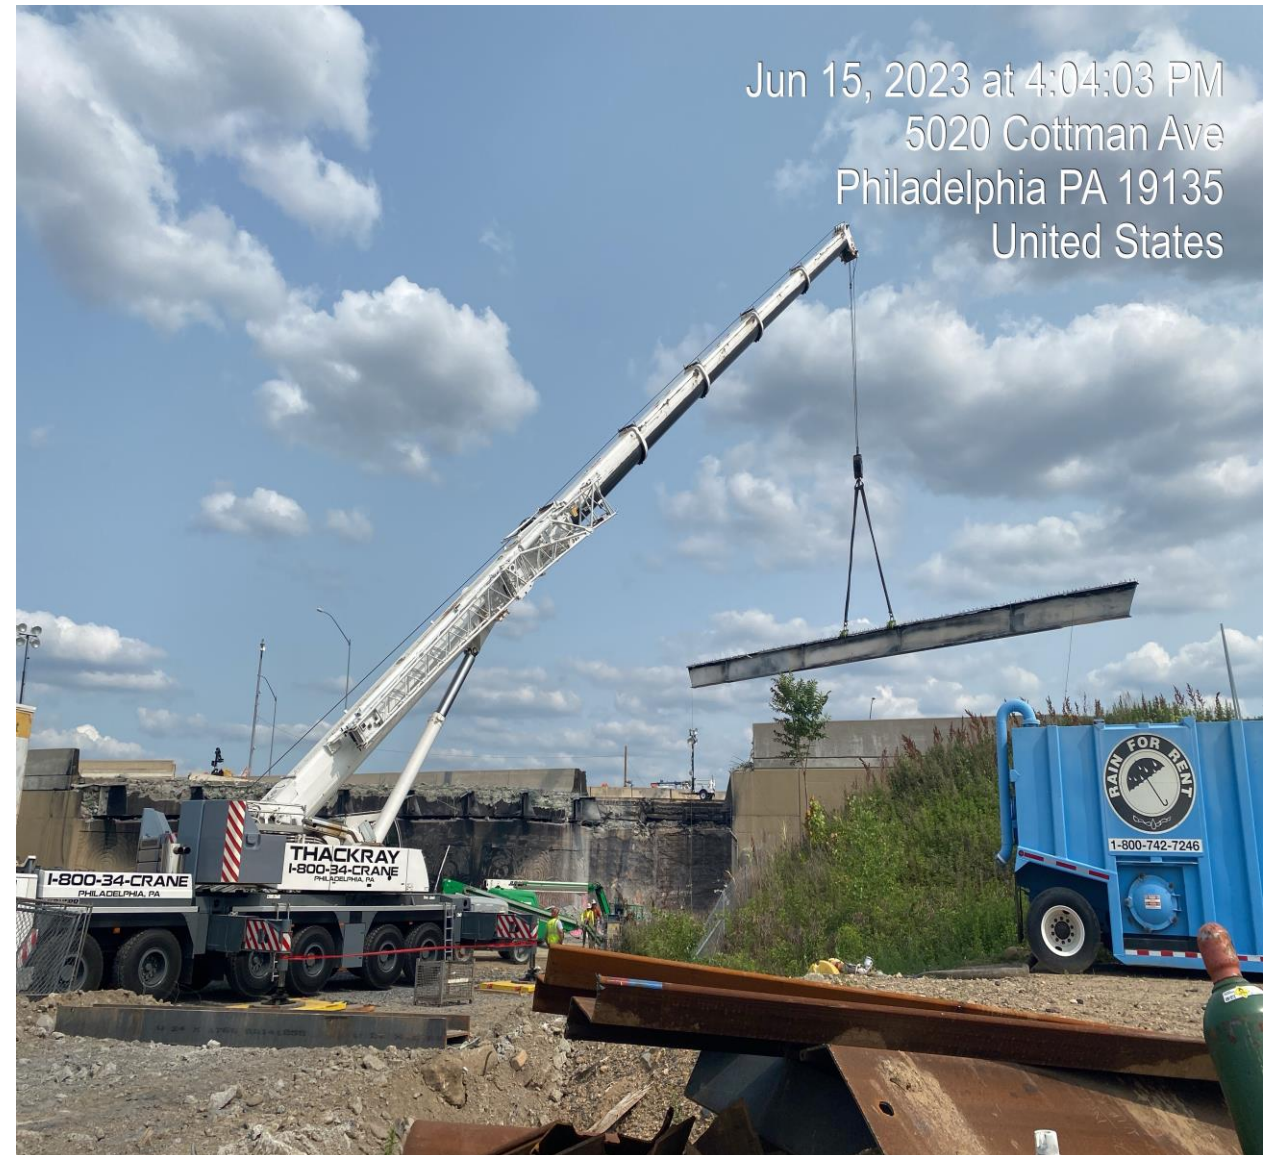
Abbonizio Construction started  
June 11 around 4:00 PM.

Approximately 783 CY or 1,585 tons of  
concrete was removed.

Approximately 139,059 lbs. of bridge  
deck reinforcing steel was removed.

Approximately 400,000 lbs. of structural  
steel was removed.

Photo of the last beam removed  
June 15 around 4:00 PM.

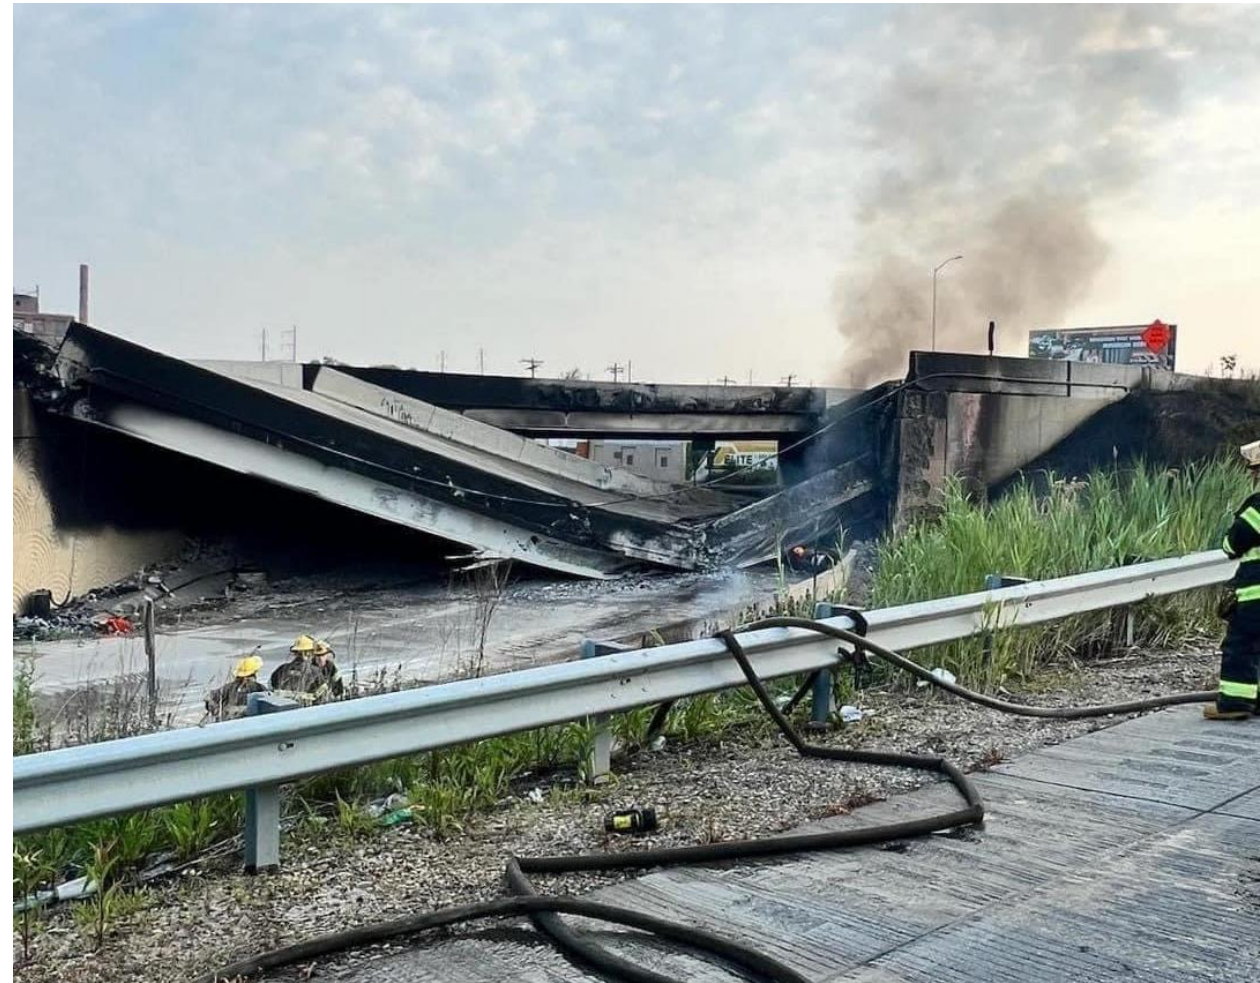
June 11, northbound collapsed.

Firemen are on the scene to keep the smoldering down.

Crash was on the east side north abutment corner.

The fuel truck hit the corner of the abutment and instantly exploded.

Fuel had leaked into the sewer system but didn't catch fire right away.

Once the fuel hit the outlet near the river, air circulated and caused an explosion, all the manhole lids popped in the air.

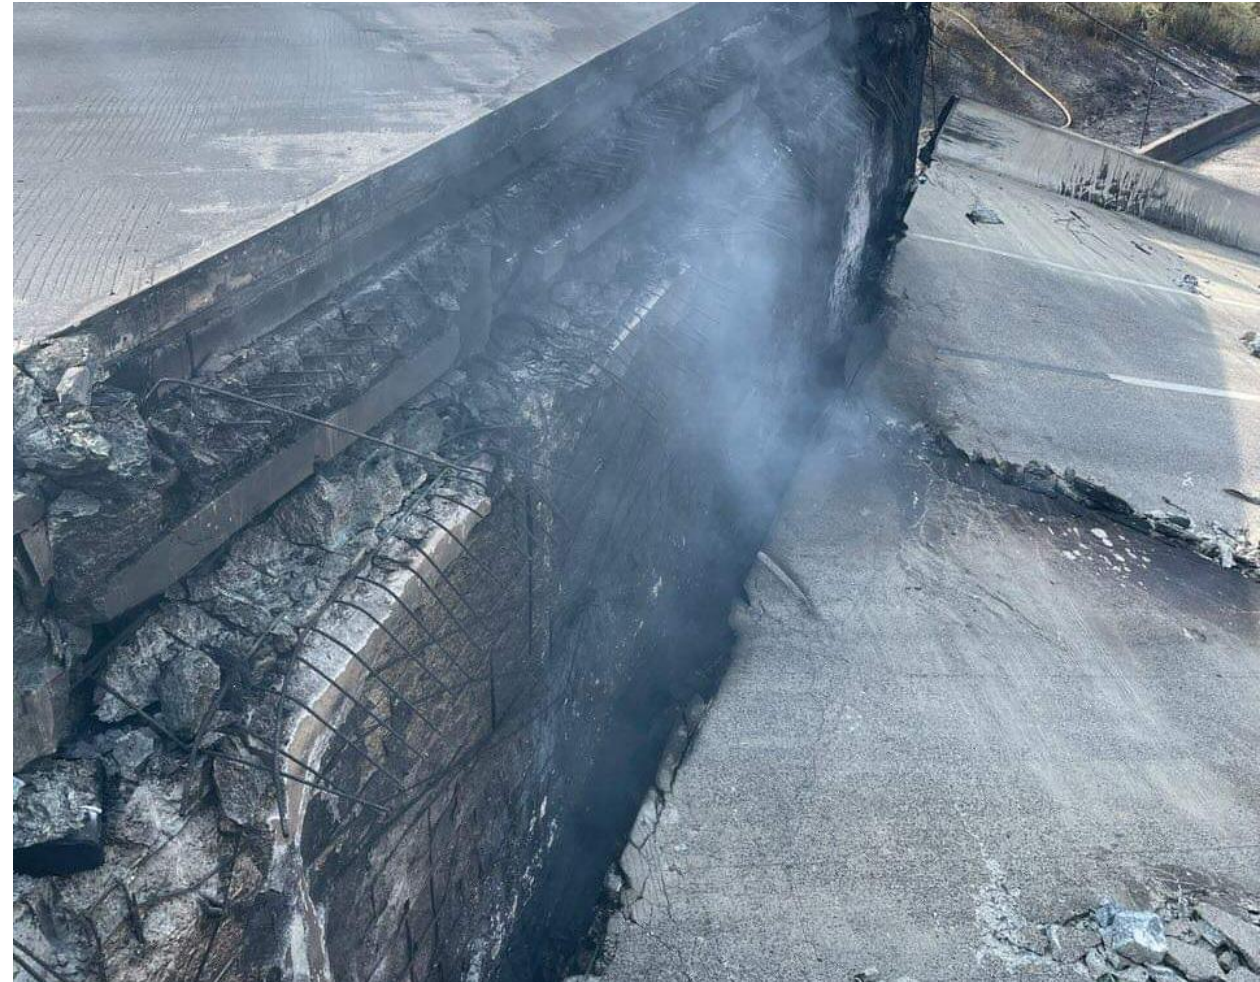
A shot of the back wall and collapse on the northbound side.

You can see this still smoldering.

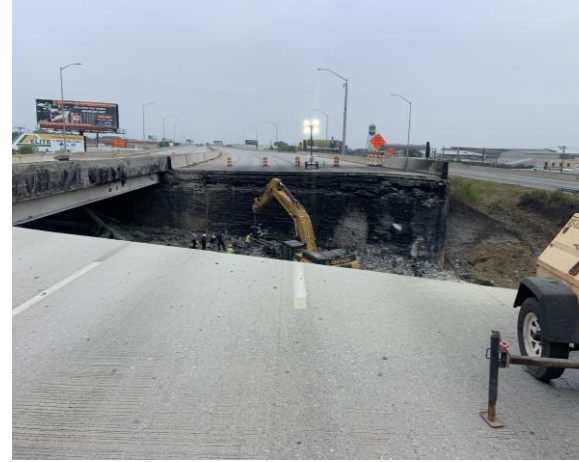
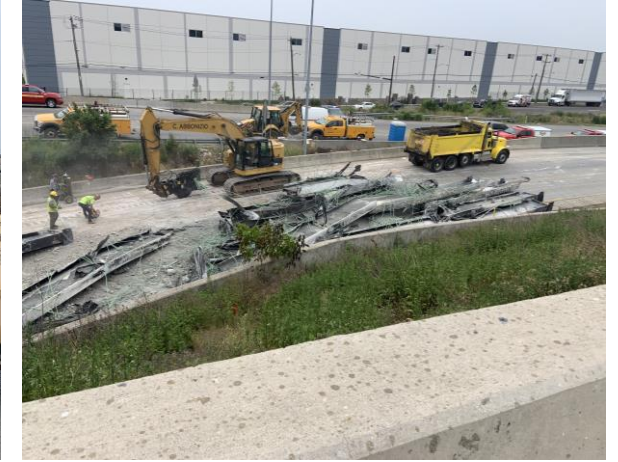
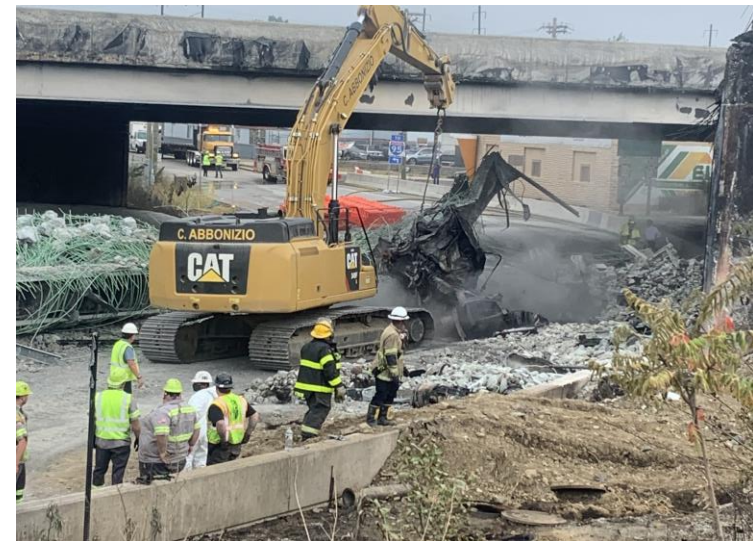
Northbound side  
demolition, burned  
beams, and the tanker.

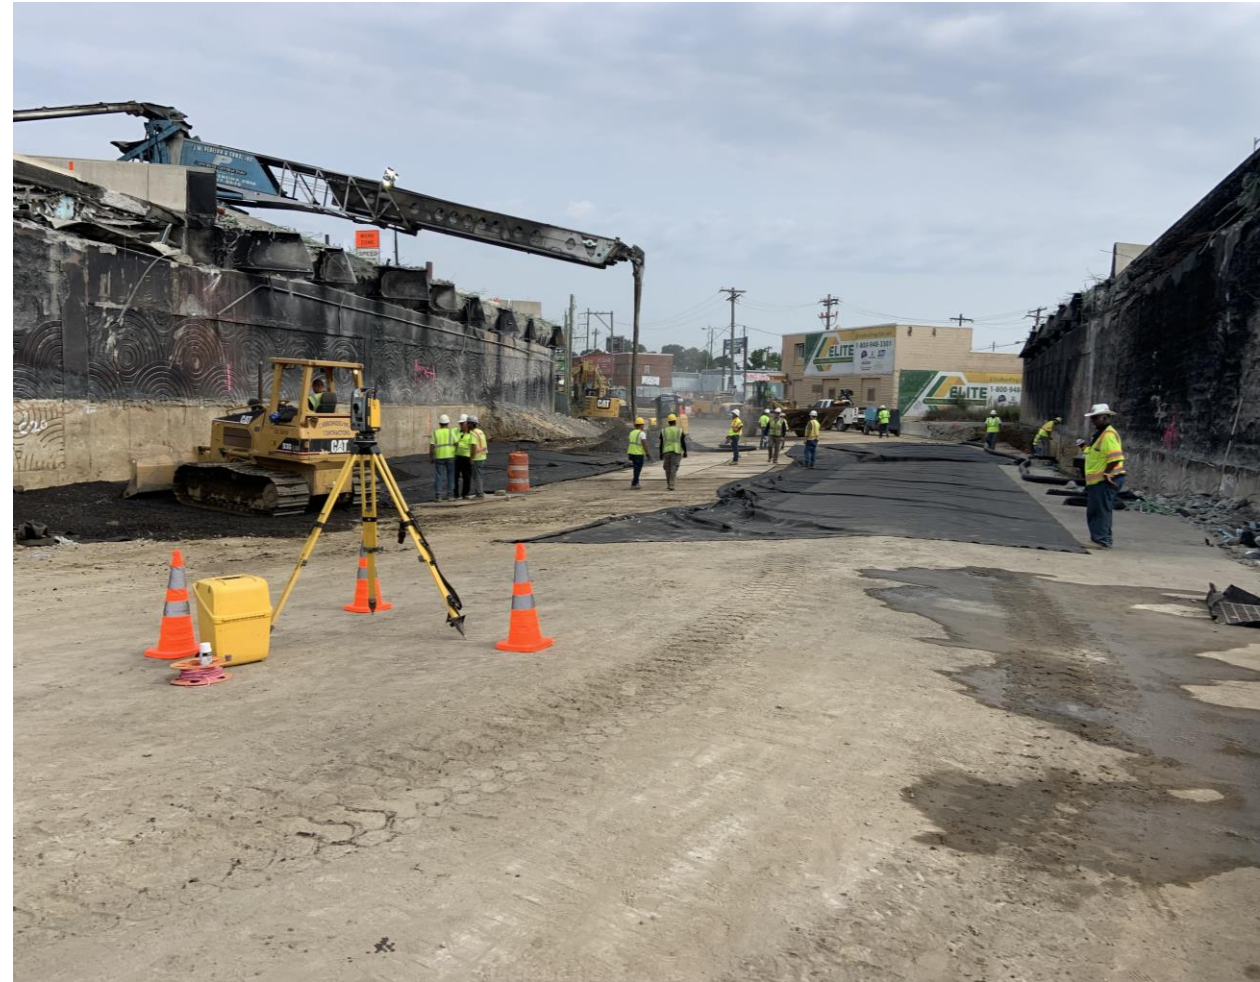
Demo completed.

Used regular 2A modified to level out the superelevation of this off-ramp.

Geo fab was installed.

Cores were taken in a grid pattern to assess the abutment wall integrity.

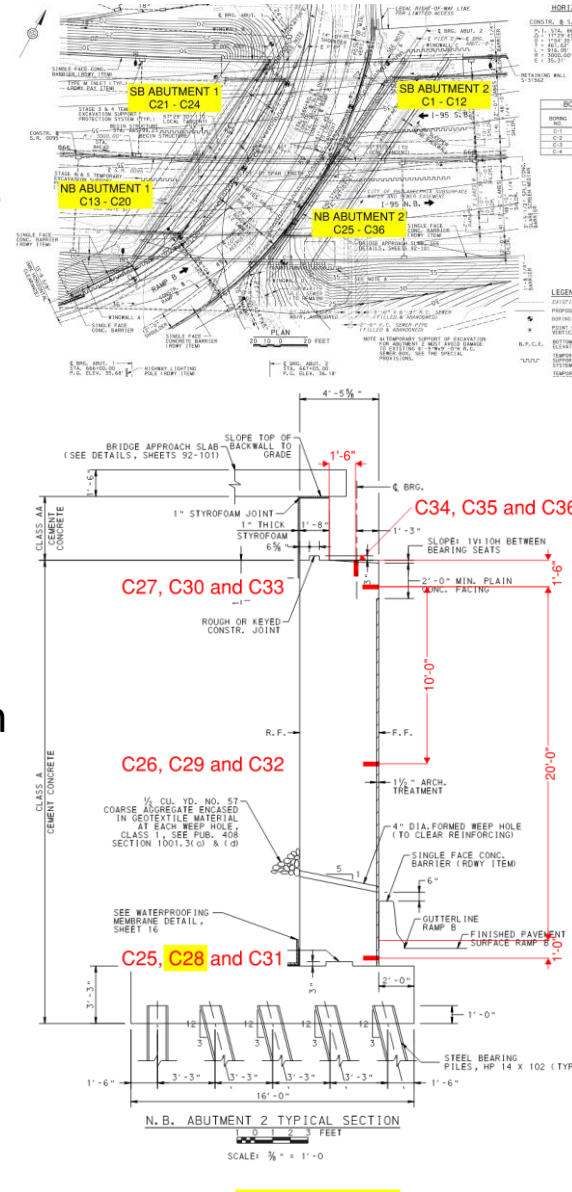
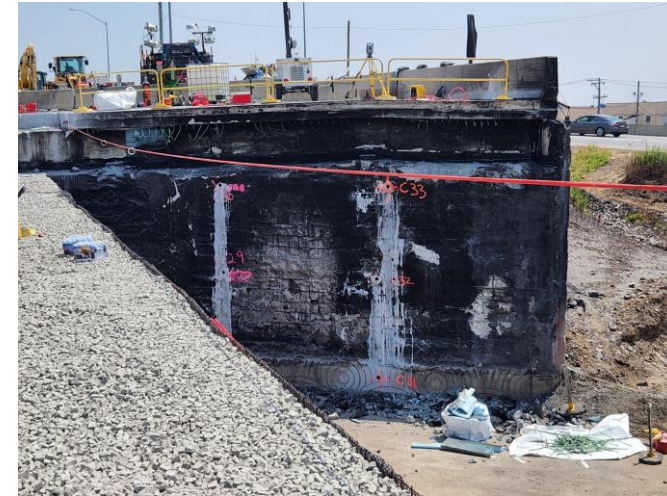
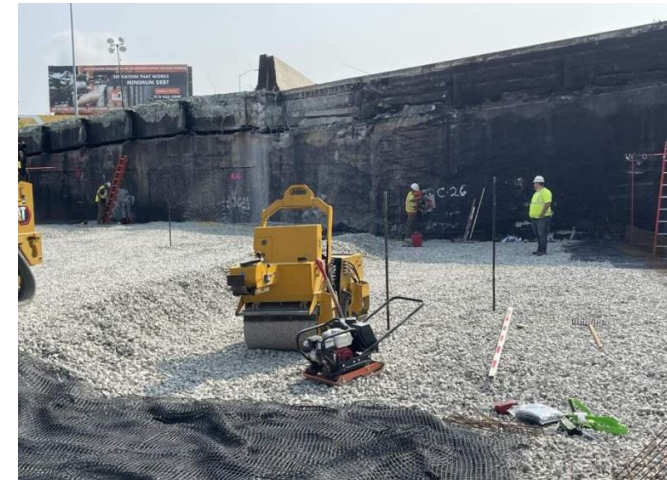
While we were constructing the temporary MSE wall, we developed a concrete coring plan for the abutments to determine extent of damage. 36 cores were taken. The North East Abutment, was the location closest to the fire and where most intense heat was located (core locations C25-C36). We requested that C25-C36 cores be tested first. At that location the post fire concrete loss was up to 5.5". Original abutment stem thickness > 4.5'.

Testing included petrographic examination to determine depth of distress beneath exposed surface (i.e. cracking, discoloration, softening of paste, alterations, etc.). Examination showed that cracking was present to a maximum depth of 1 ½", thusly we would be required to remove approximately 6 ½" from the form liner face. This supported reuse of the existing abutments.

Compressive strength testing results ranged from 5070 psi to 6610 psi well in excess of Class A strength requirements.

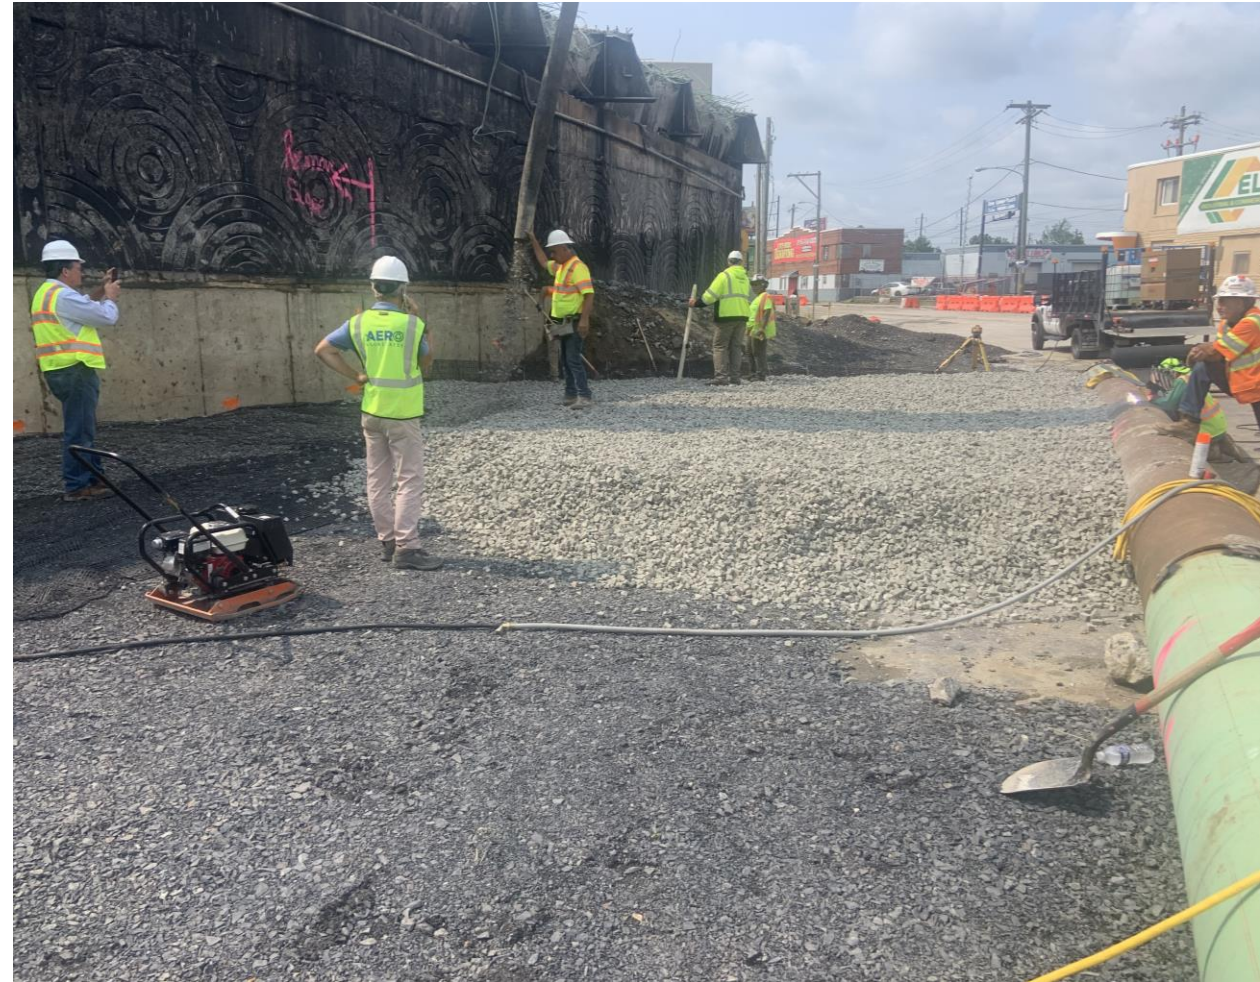
Backfilling was done with 2 telescoping conveyer belts with tremies.

18" +/- lifts were installed.

This material does not get compacted, it gets consolidated.

Rubber tracked Skidsteers ran over the material 3 to 4 times to knit the material in.

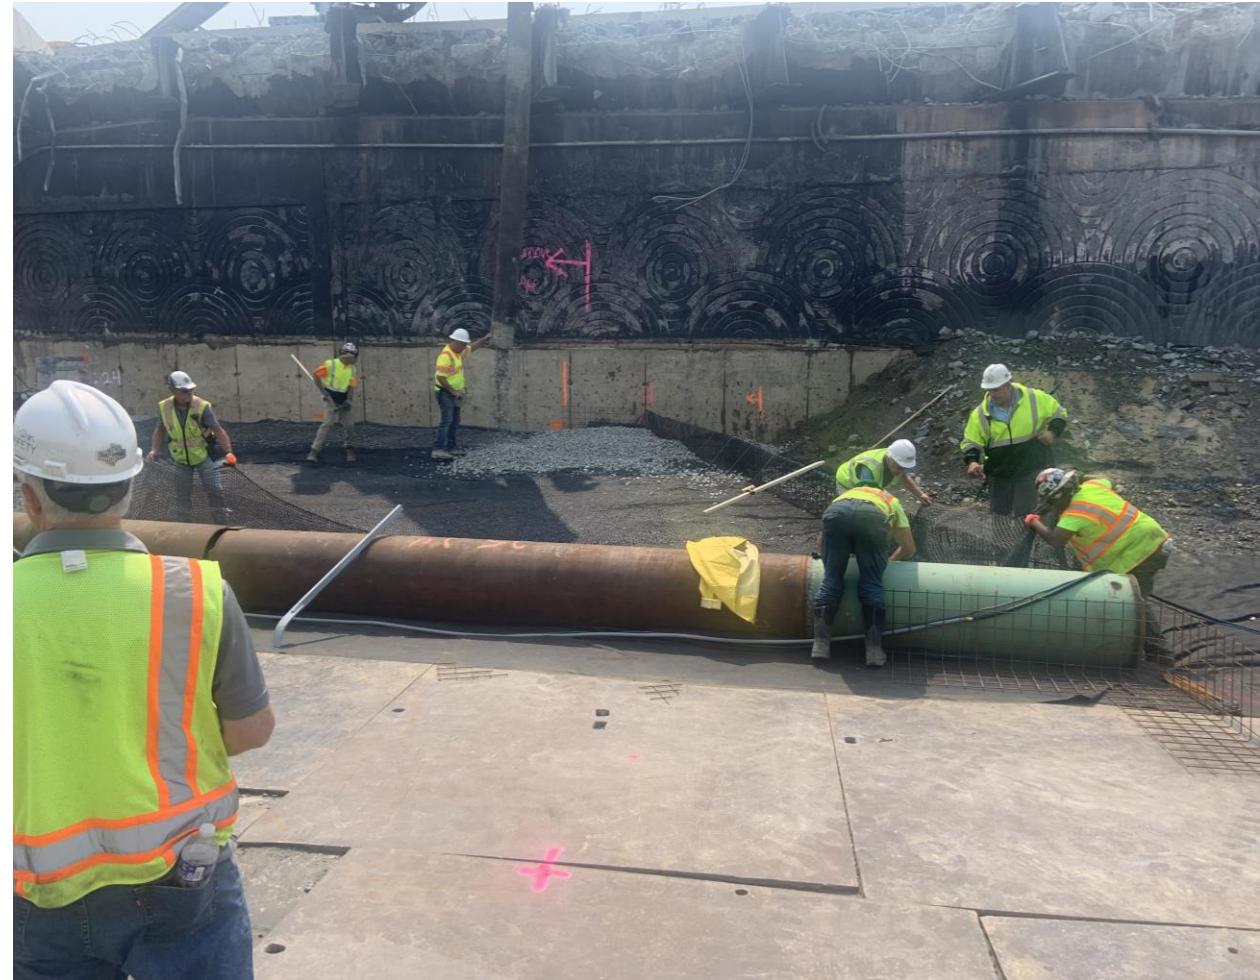
The unsung hero of this process was the wire wall and geogrid.

The wire wall was installed at the ends with angle bars to keep the 90 intact.

The geogrid was installed up the sides and along the bottom.

This created a cradle for the stone and its where its strength comes from.

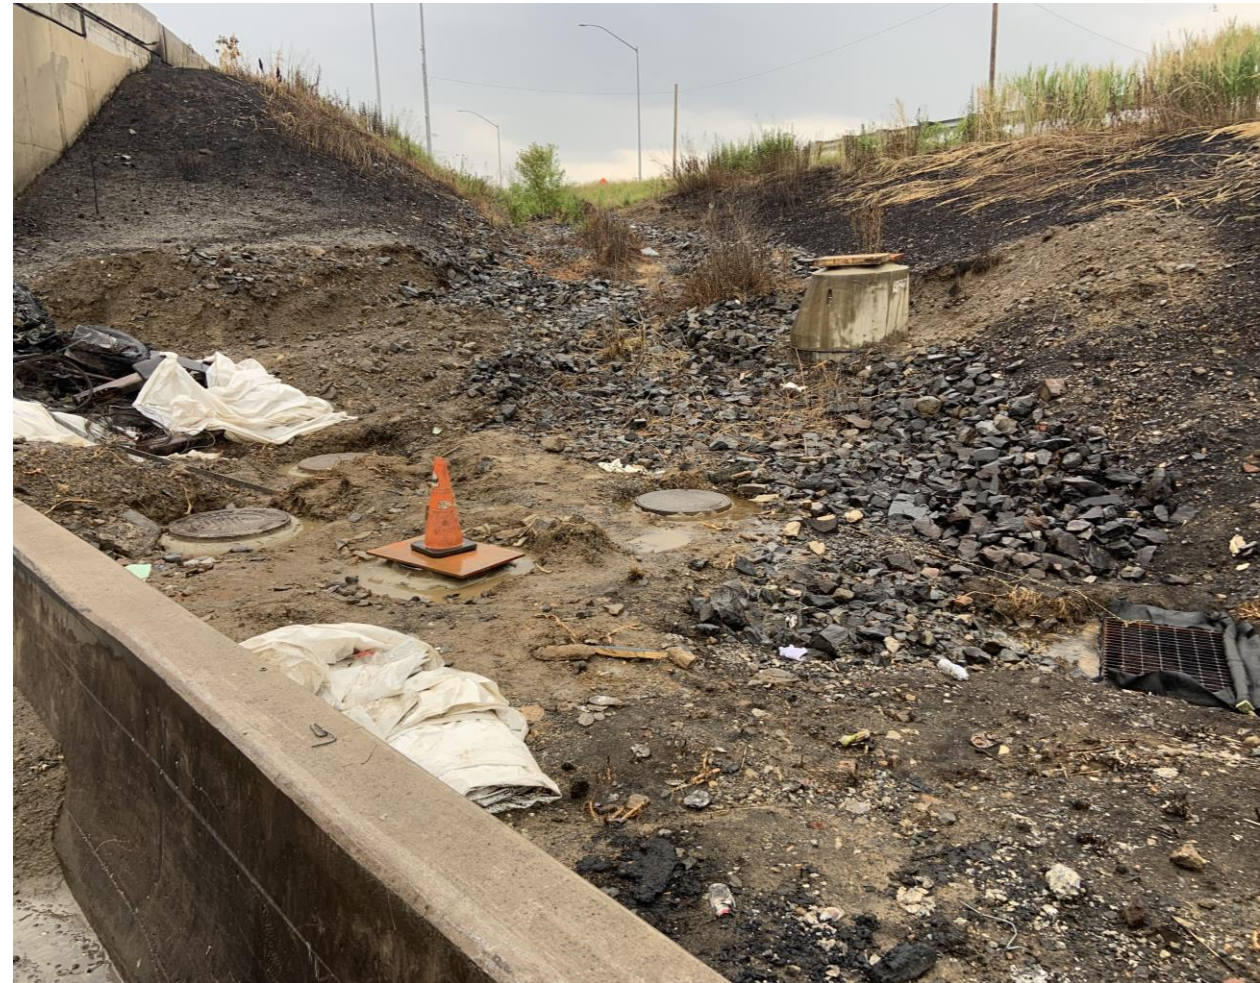
Manhole lids replaced.

These were blown off in the explosion.

The gas leaked down the storm sewer and out to the river.

It didn't ignite until it reached the river and oxygen was introduced.

This caused a back draft sending our manholes straight up in the air.

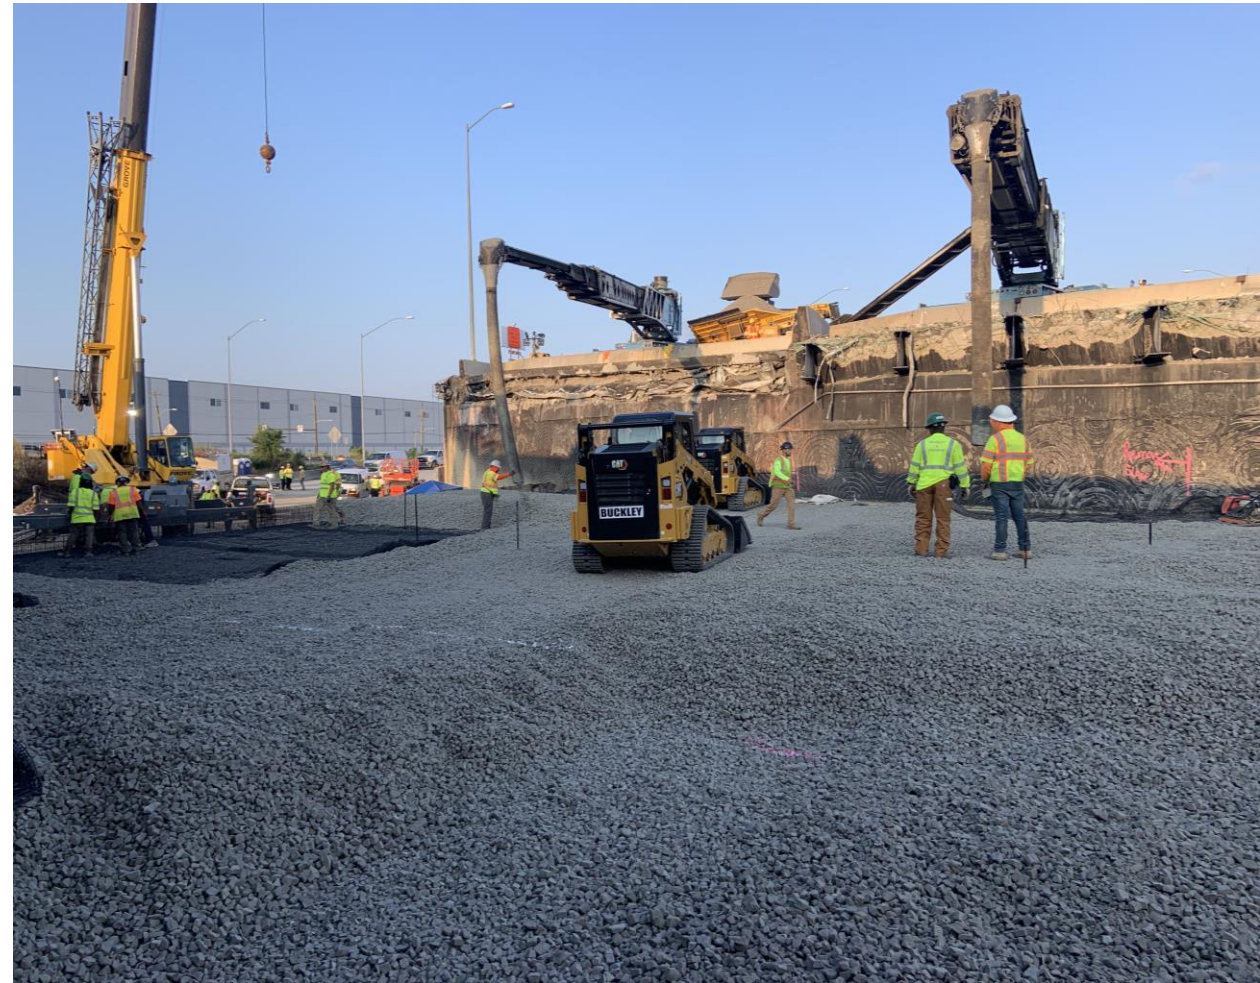
Settlement rods were installed. They were shot a few times a day. This was to see if there was any settlement to the roadway underneath as we placed this stone.
