# REBUILDING I-95

# I-95 TANKER FIRE & BRIDGE COLLAPSE

Philadelphia, PA

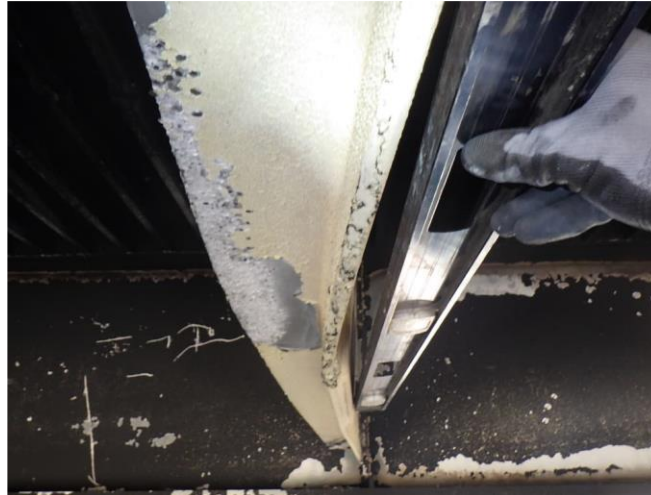
Intermediate cross frame diaphragms severe distortion throughout.

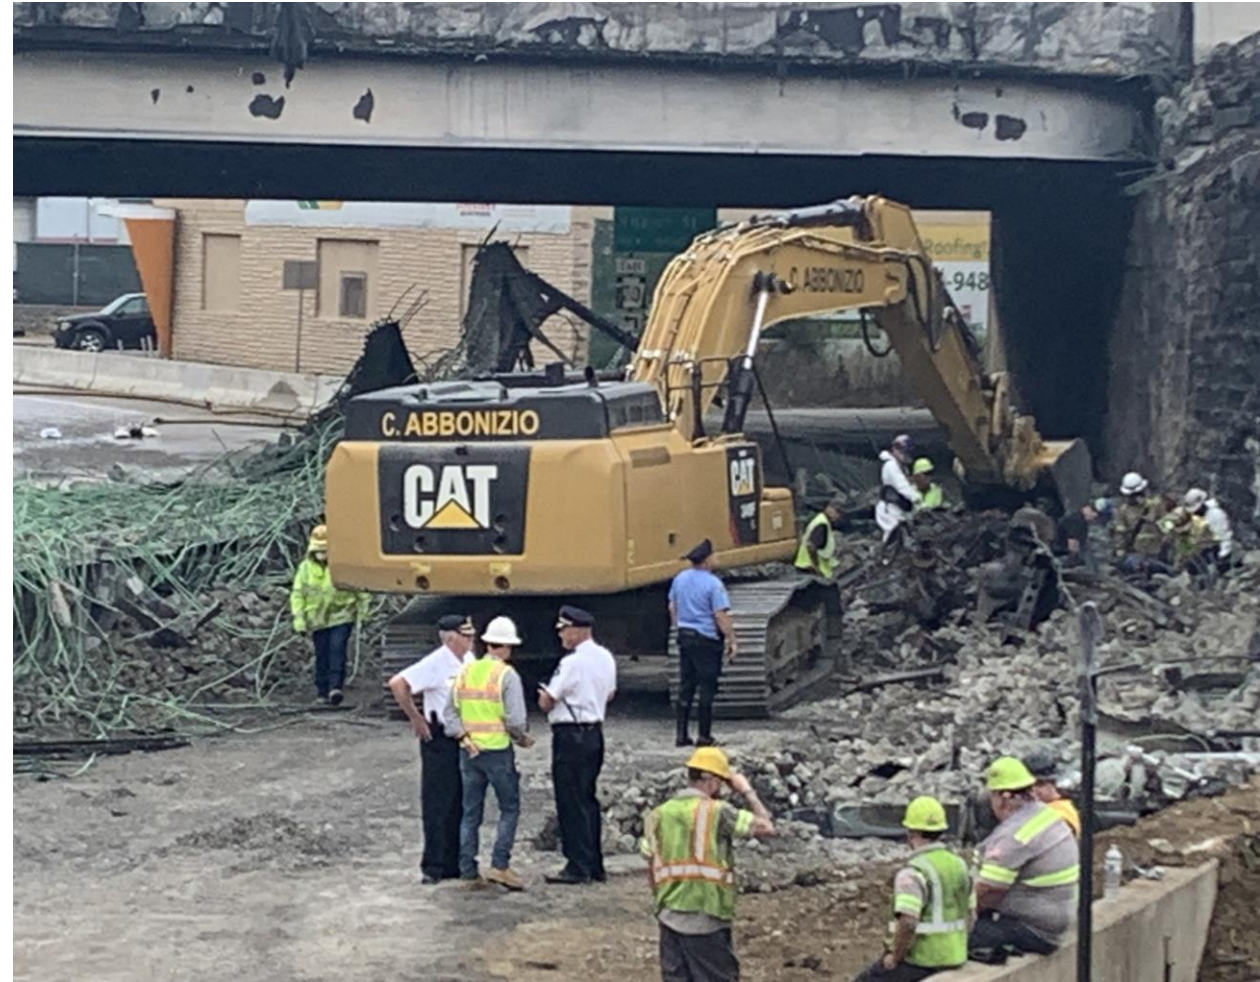
Carefully demoed to see if they could find the other vehicle.

No other vehicle was found.

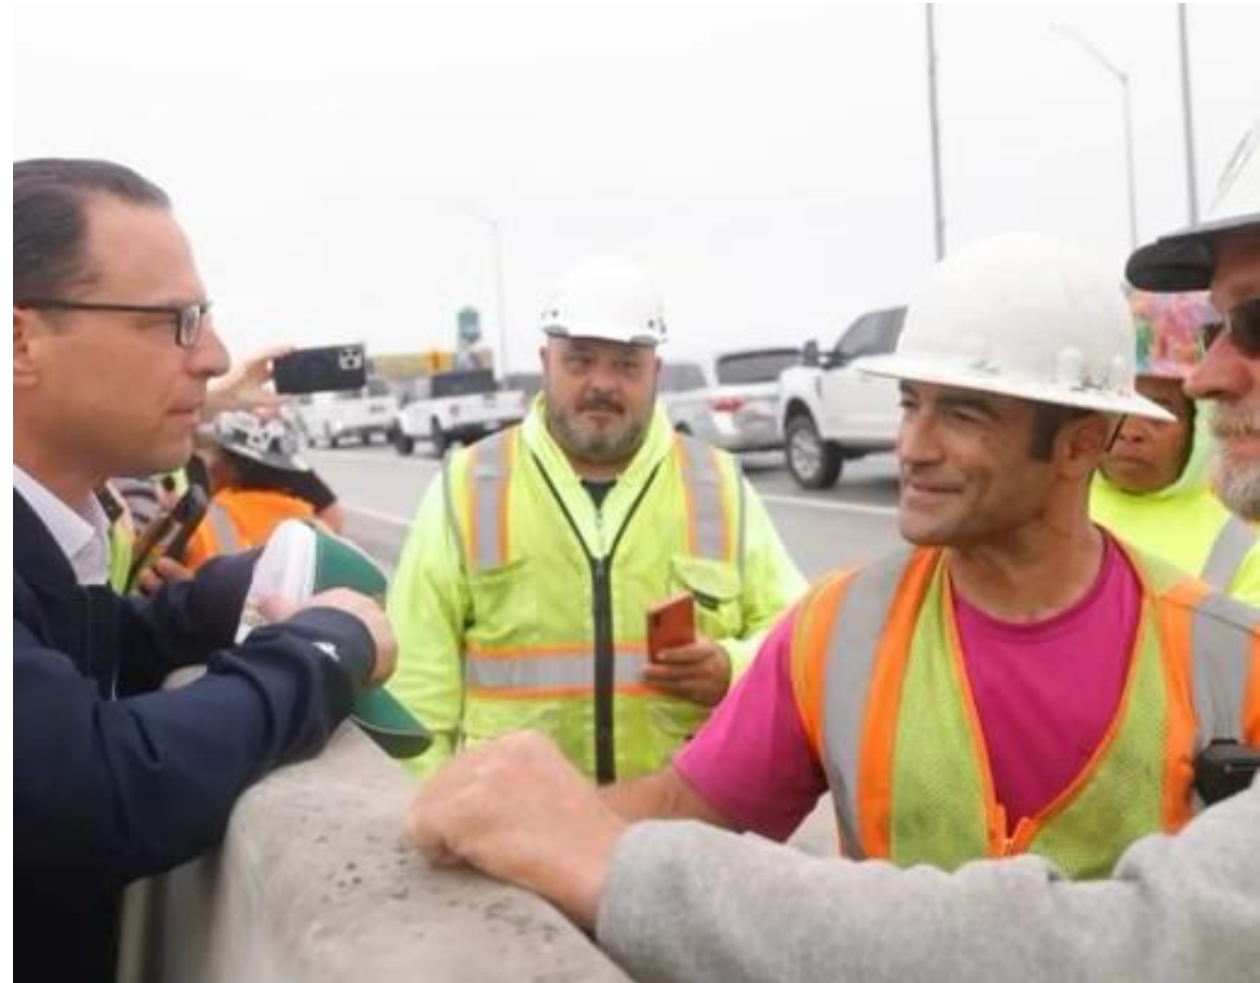
# TUESDAY - JUNE 13

Cleaning the northbound side. Deck removals of the southbound side begin.

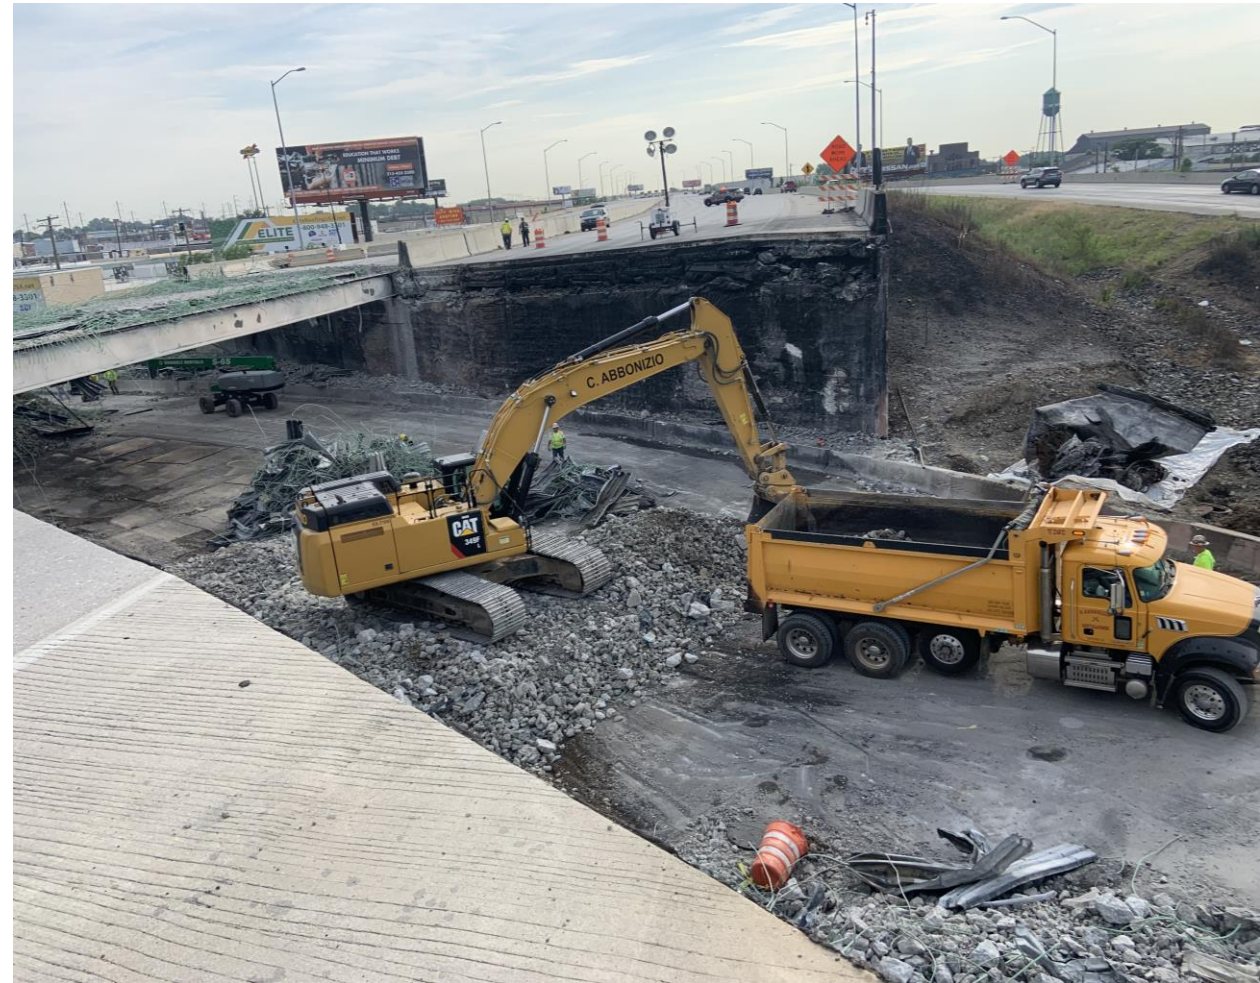
# WEDNESDAY - JUNE 14

Southbound side deck removal. The contractor elected to peck and remove the deck from the top side.

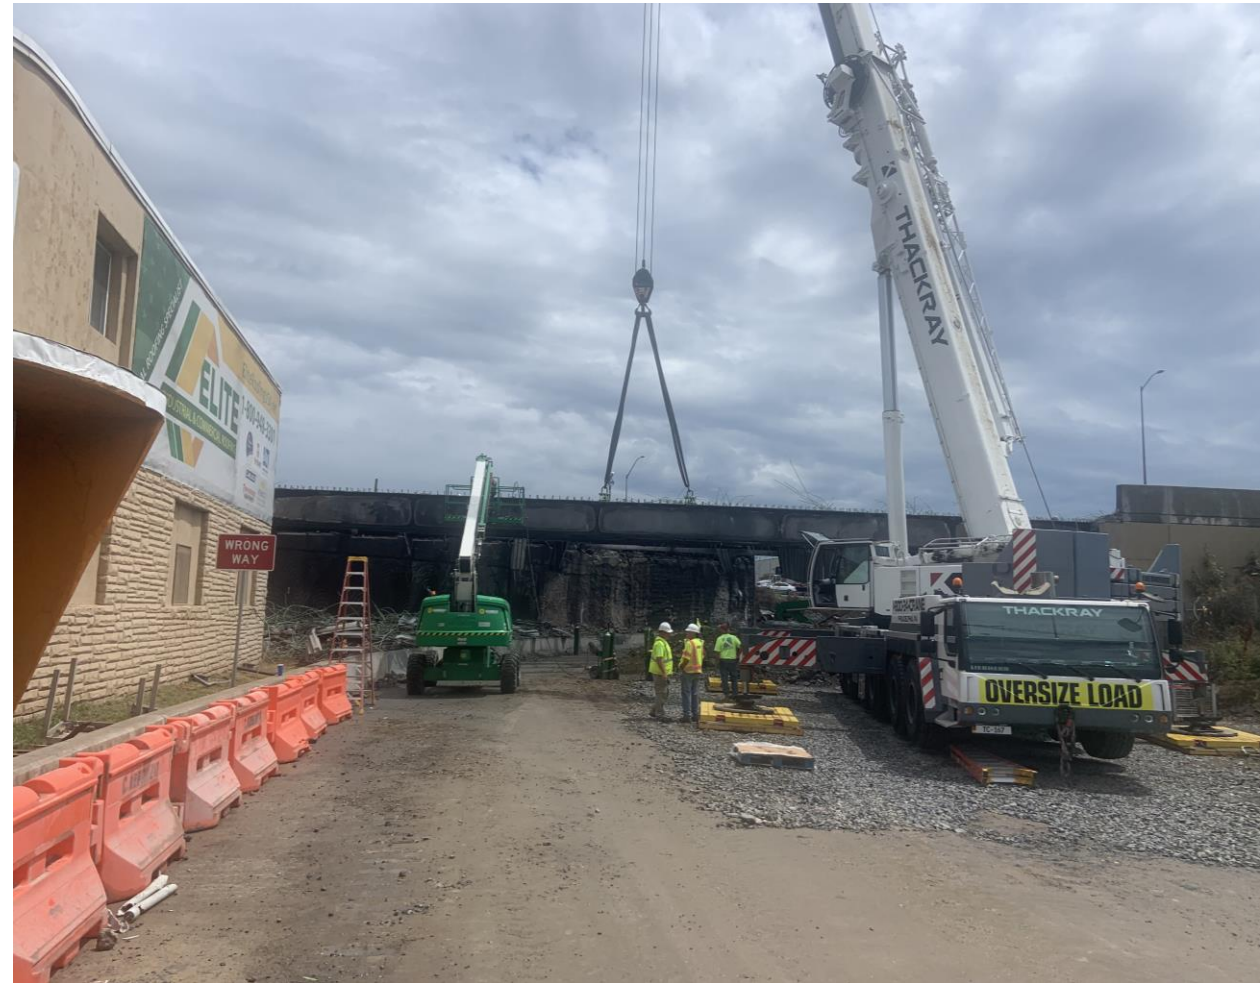
# WEDNESDAY - JUNE 14

Deck is being cleaned.  
Beam 1 getting ready to be picked.

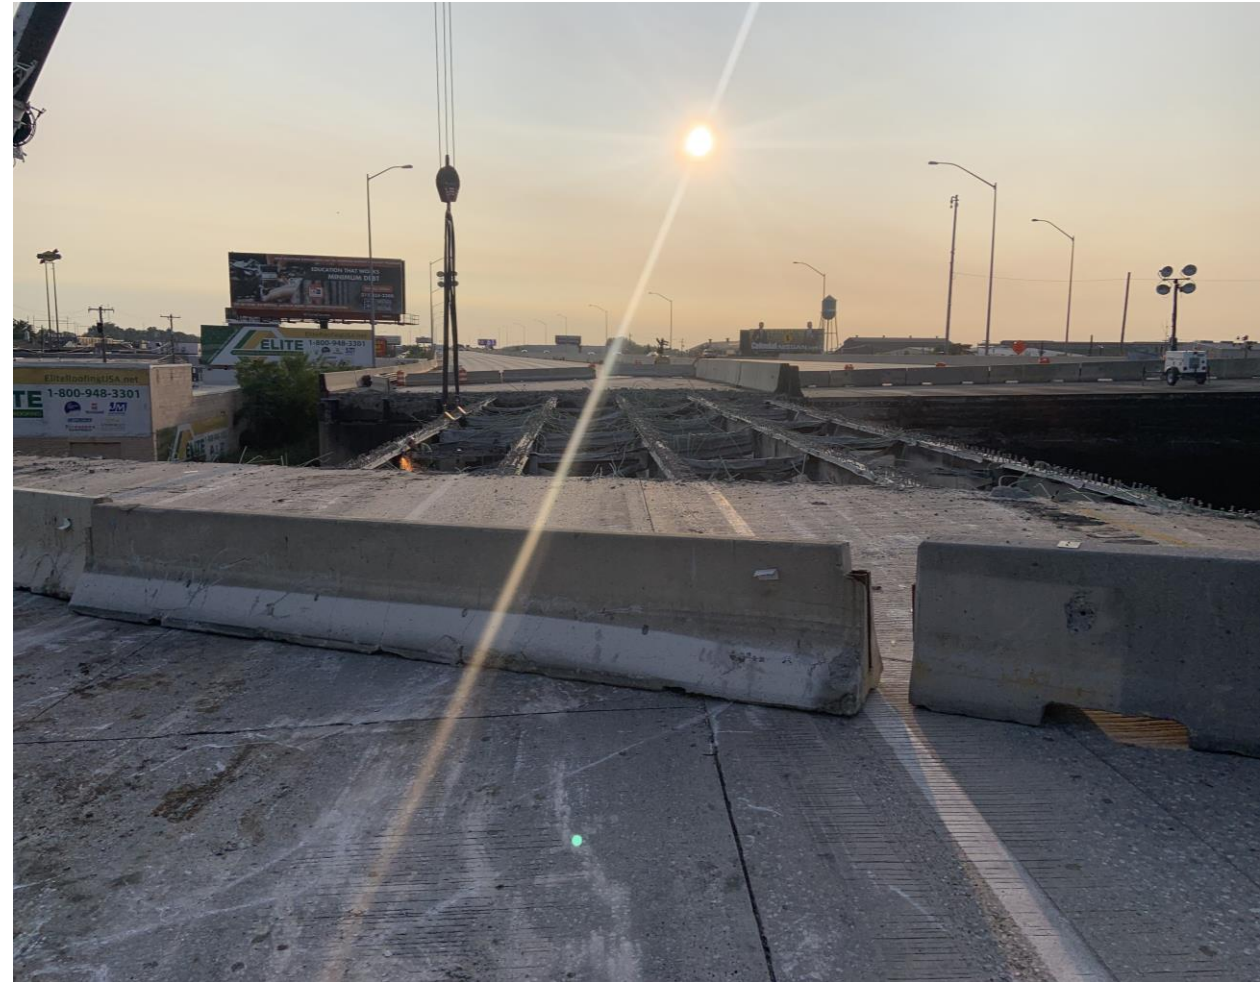
# THURSDAY - JUNE 15

Beam 3 is being removed.

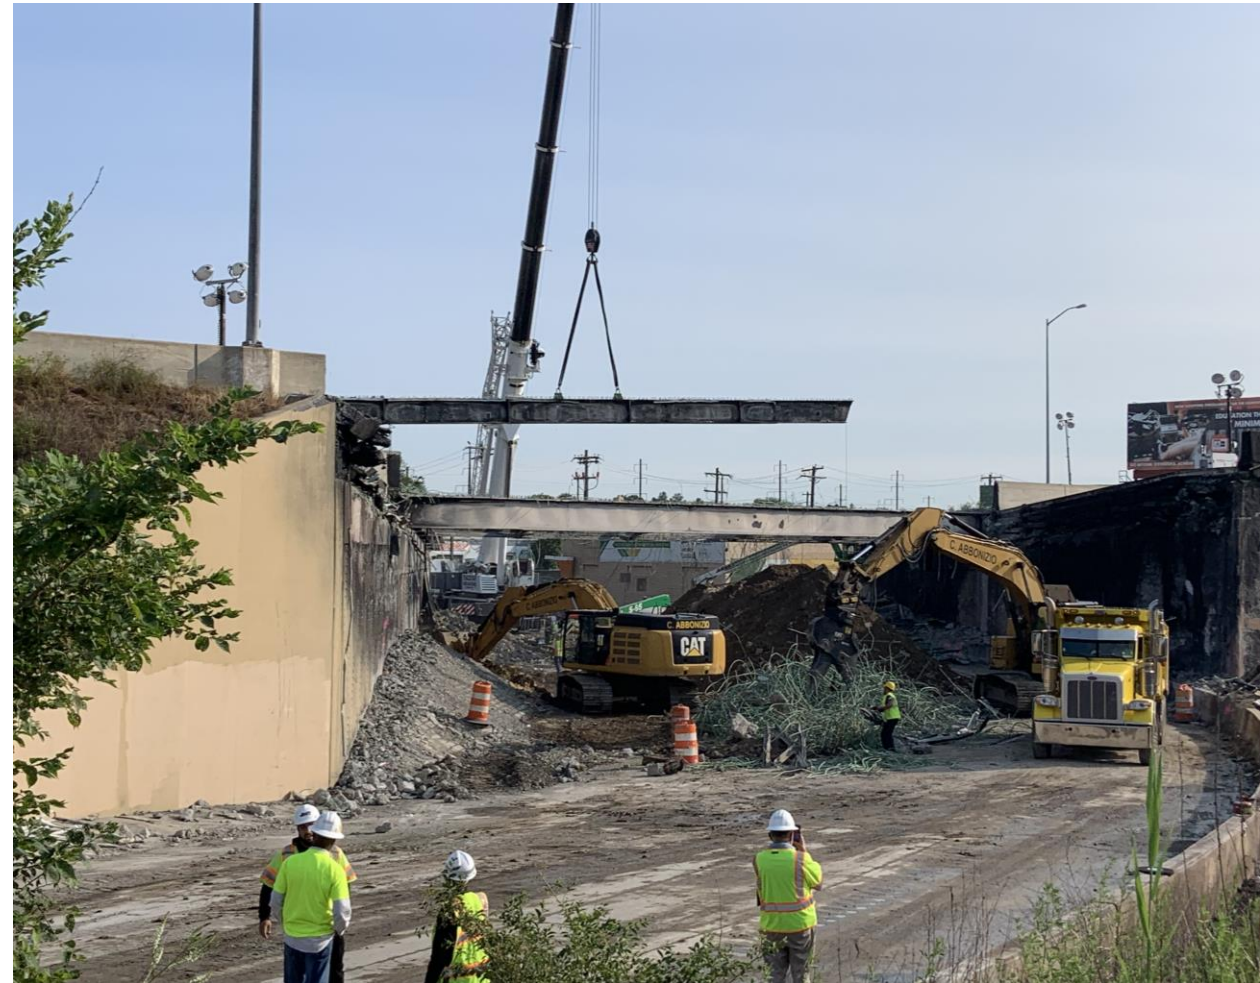
# THURSDAY - JUNE 15

Dirt was hauled in to protect the underground utilities during the demo.

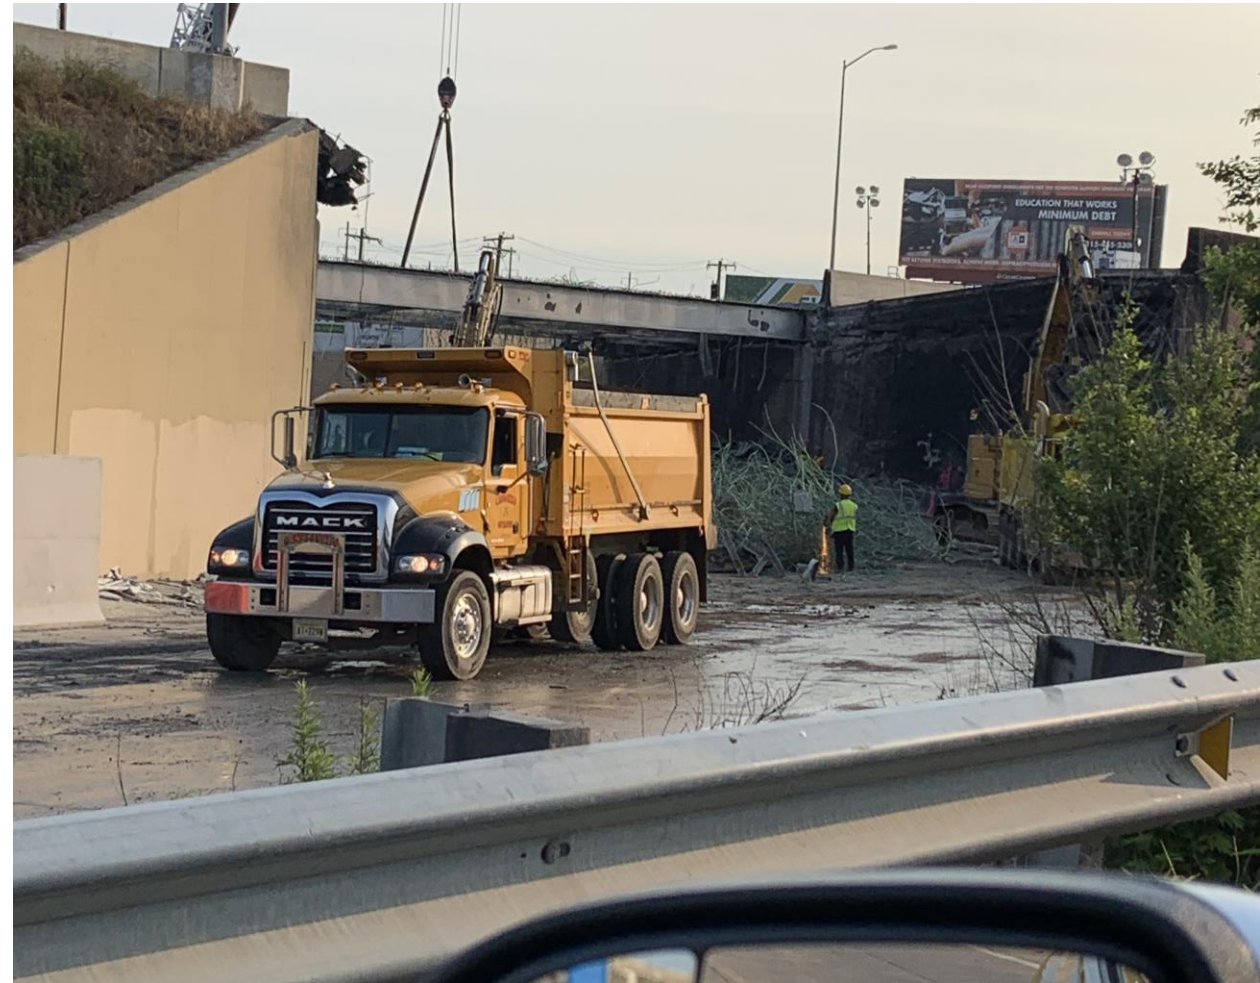
# THURSDAY - JUNE 15

Beams continue to be picked. Gather up the rebar to be hauled away.

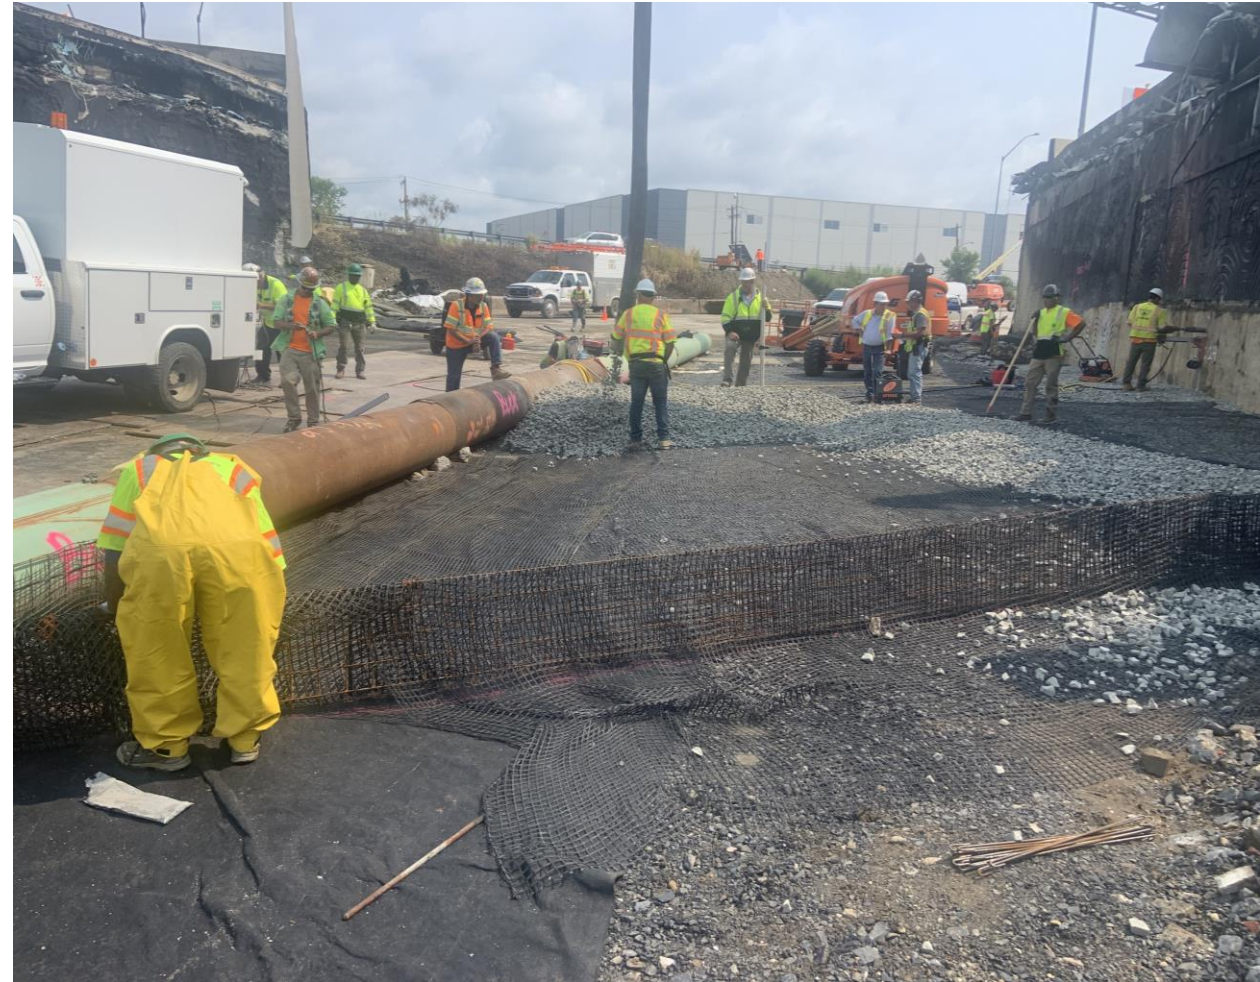
# FRIDAY - JUNE 16

Backfilling of the lightweight aggregate begins. A 24" bypass pipe was installed. This was preventative maintenance in case the water line under the ramp was compromised from the construction.

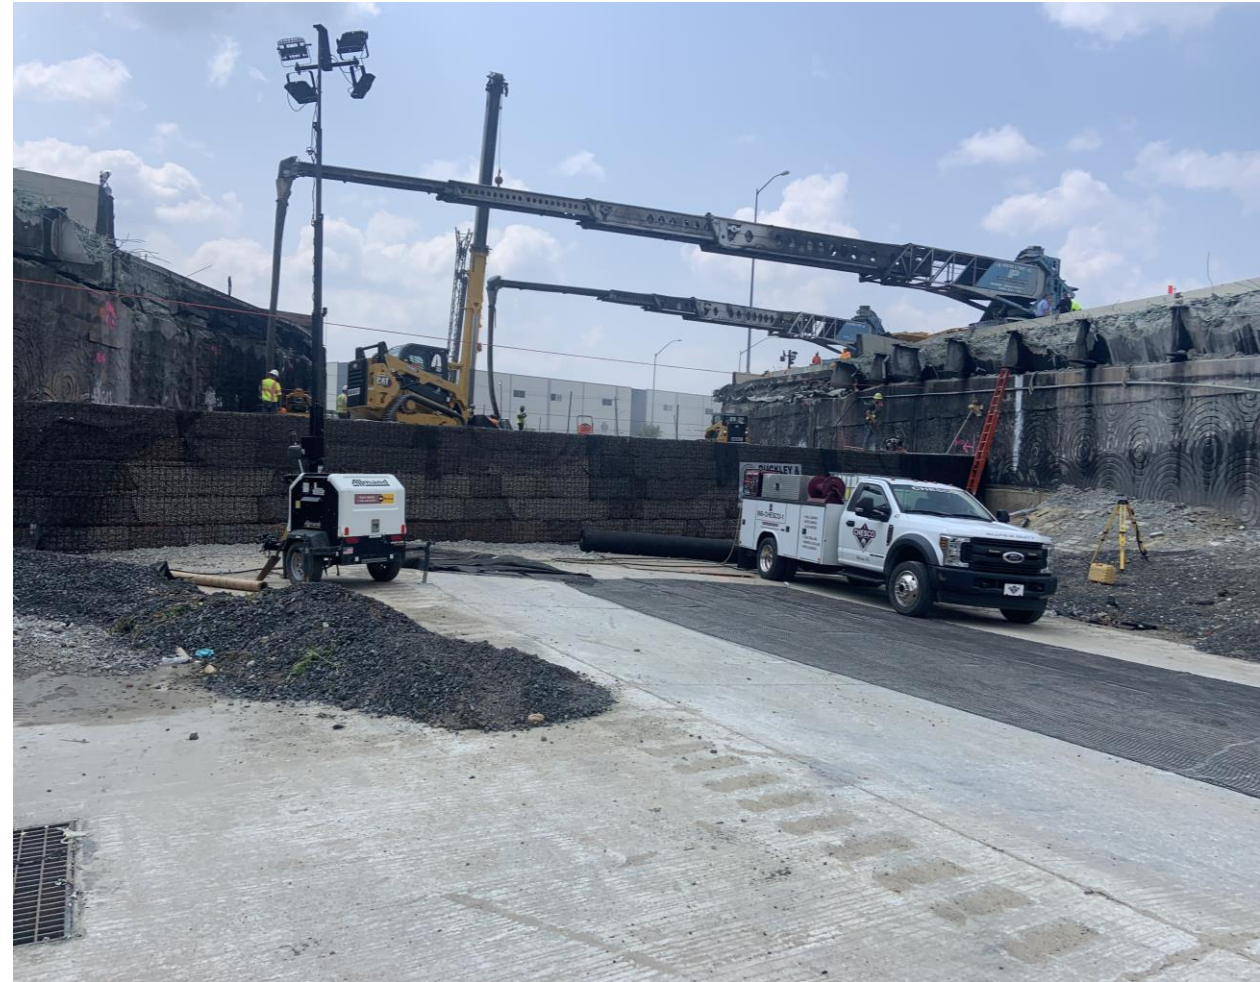
# SATURDAY - JUNE 17

Apx layer 5. Due to the superelevation, the first few layers took longer to install. Once level, we gained production.

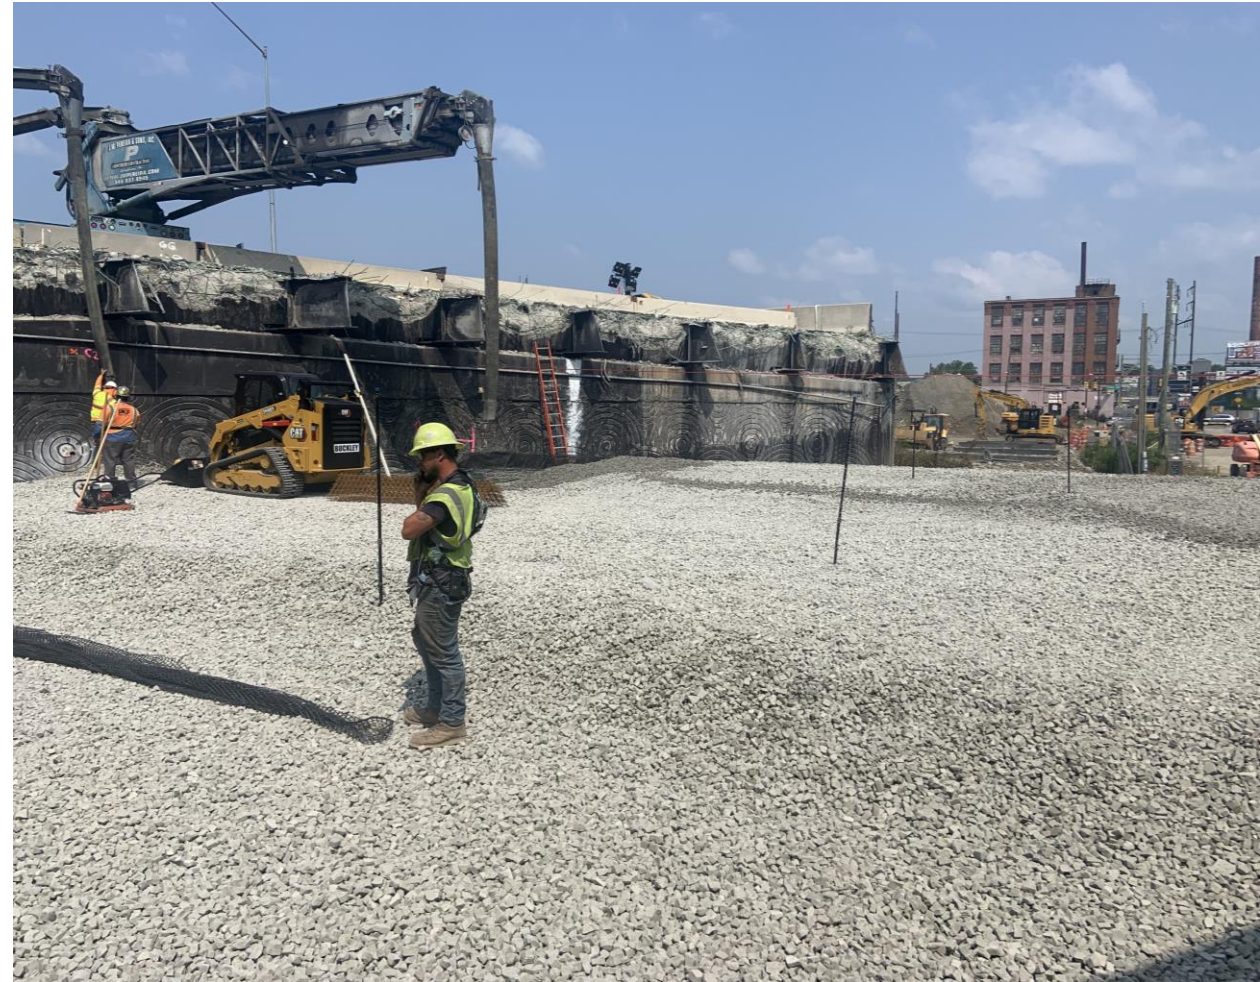
# SATURDAY - JUNE 17

Settlement rods extended.  
Skidsteer consolidating.

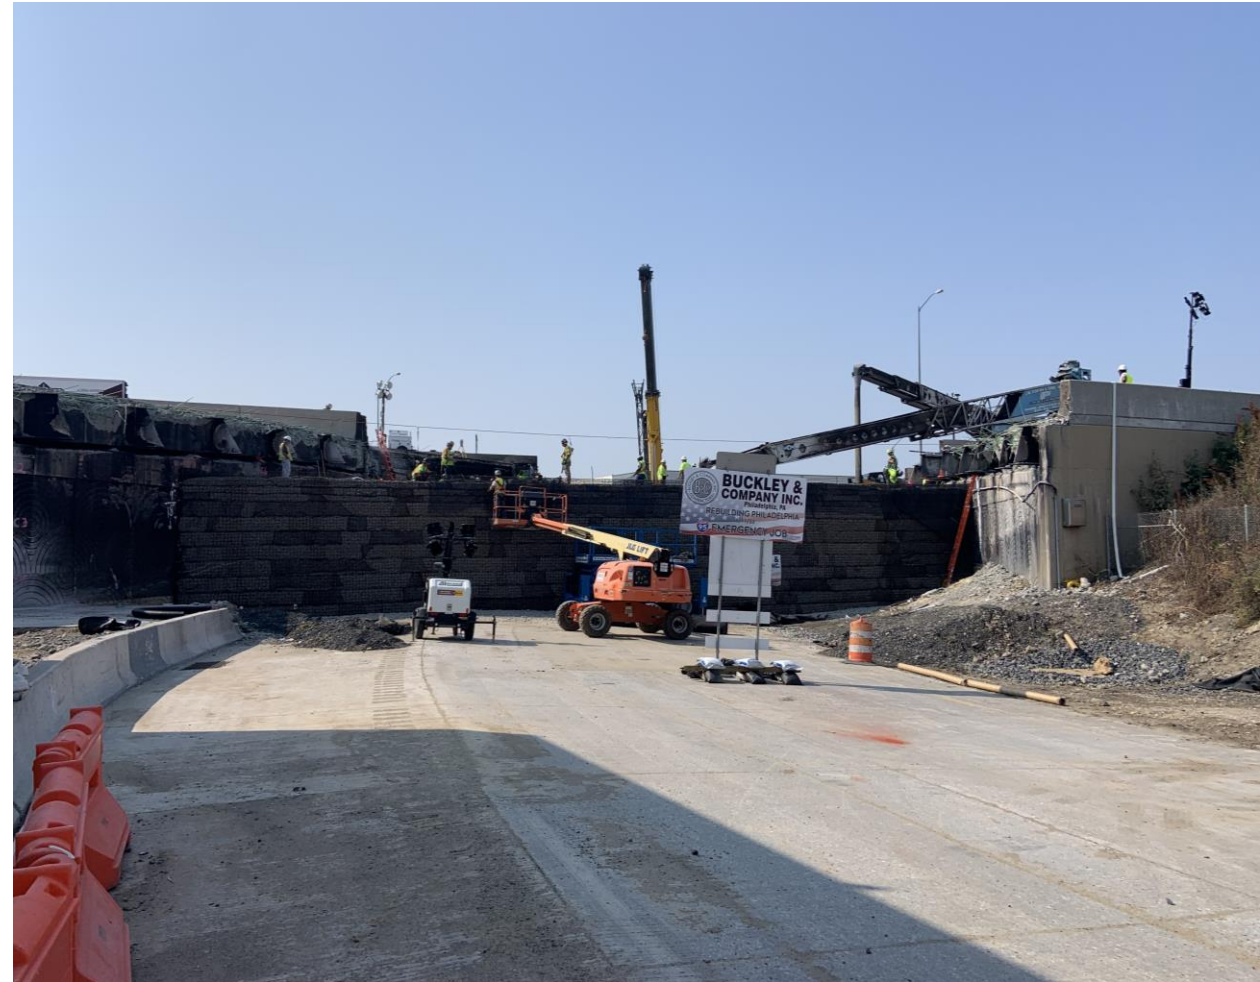
# SUNDAY - JUNE 18

Nearing the top. Production slowed down. Going from level baskets to now match existing roadway.

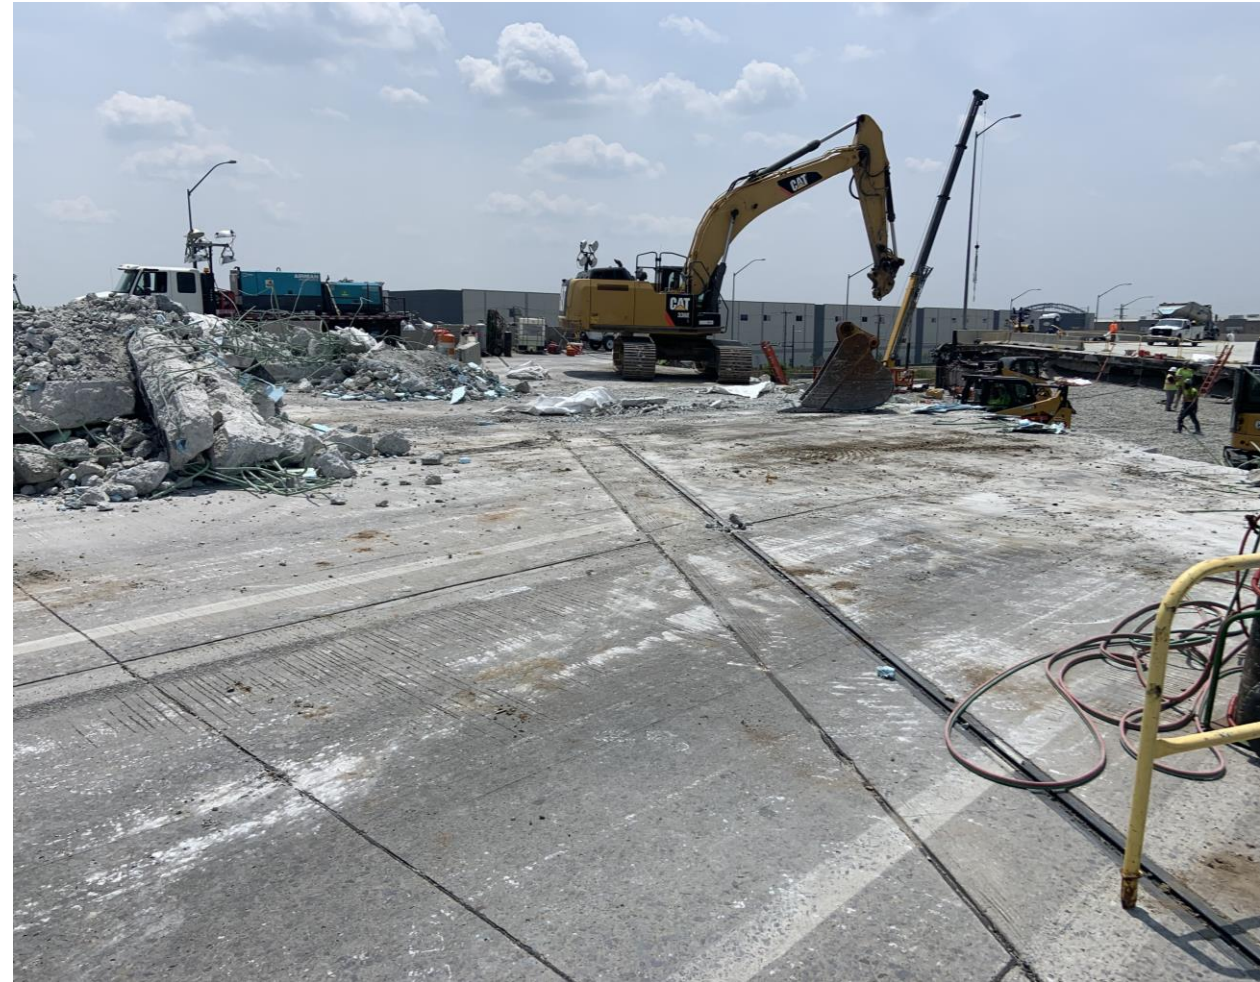
# MONDAY - JUNE 19

Existing deck and median barrier demoed to tie in the prefab median going across the temporary roadway.

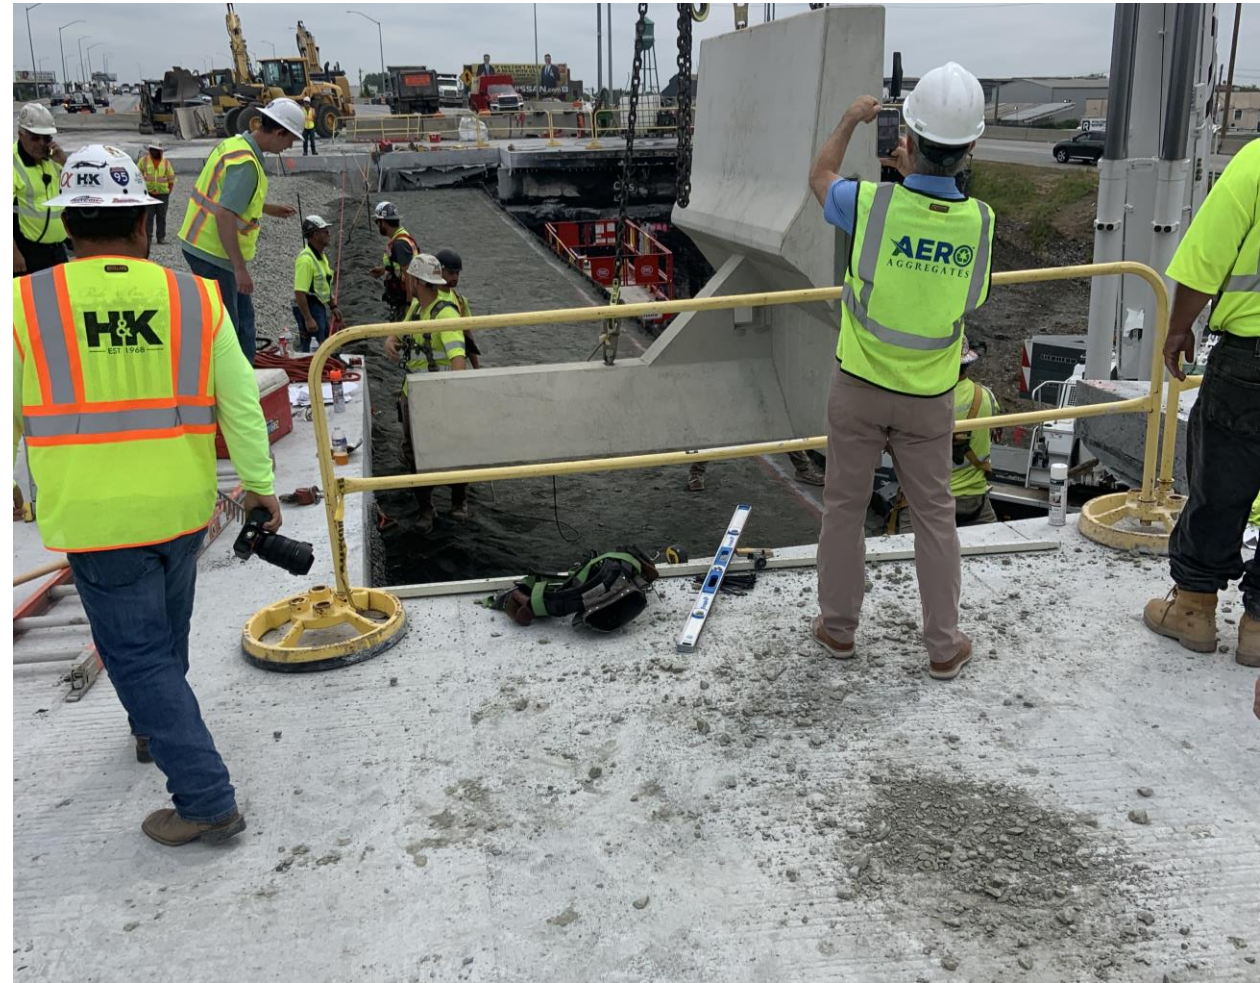
# TUESDAY - JUNE 20

The first piece is set. These pieces were already made and borrowed from another job.

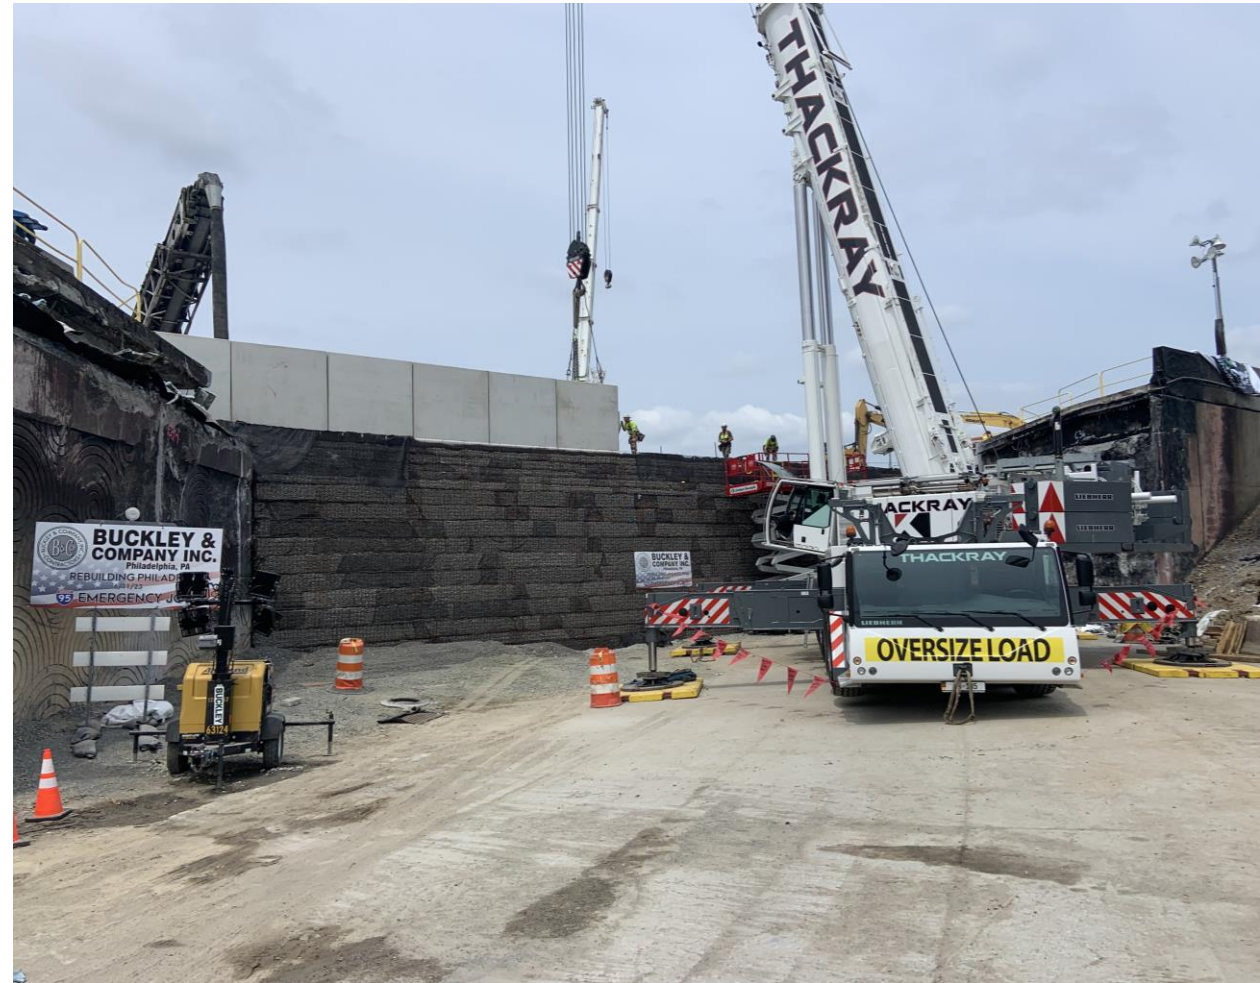
# TUESDAY - JUNE 20

Six pieces were installed on the northbound side. The crew is starting to pick up the production now. Backfilling as we go.

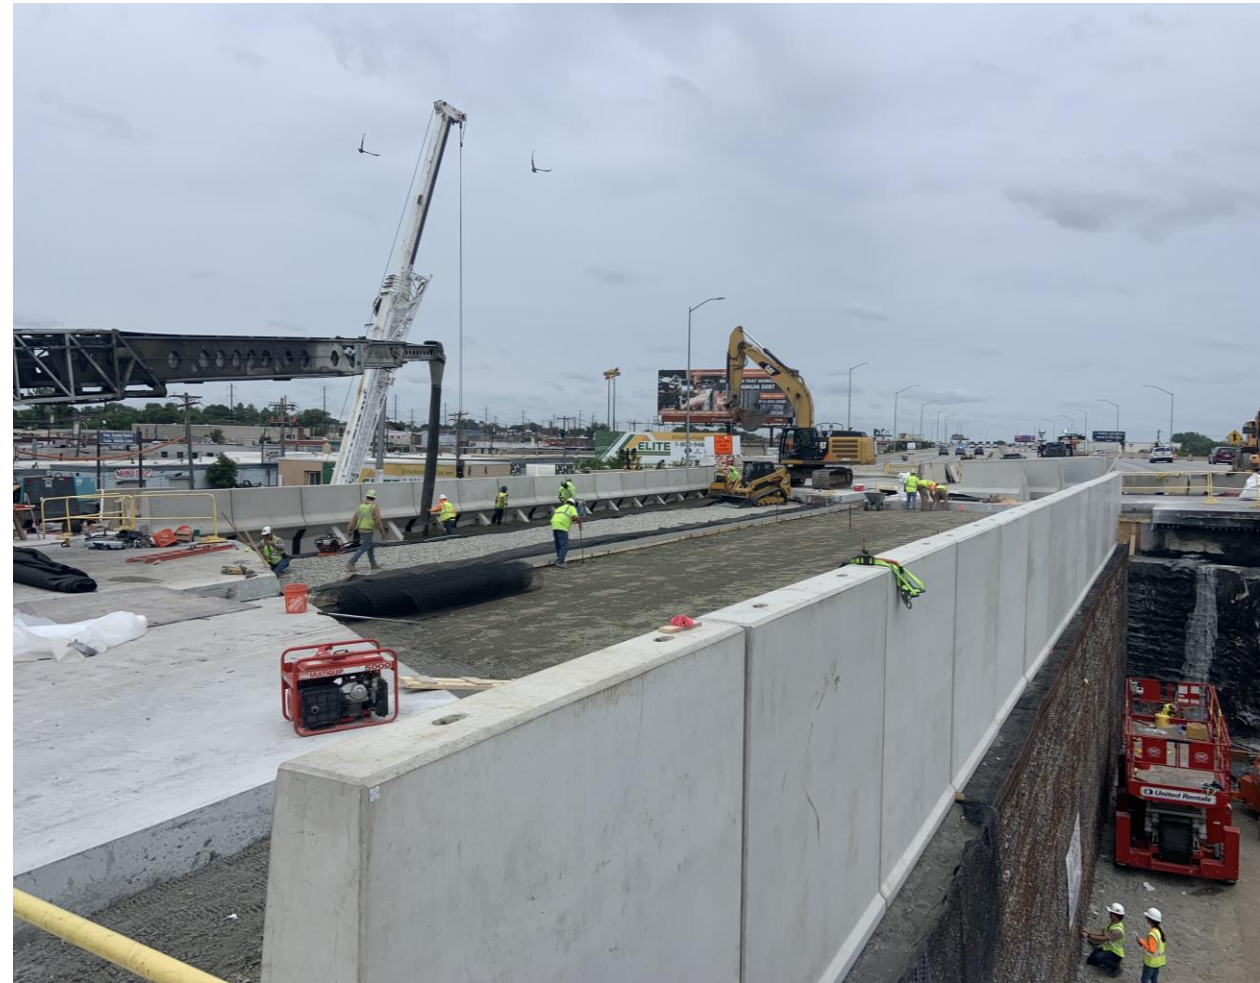
# WEDNESDAY - JUNE 21

A concert leveling pad was installed for the median barrier.

Backfilling with modified continues.

Down to the bottom right, survey markers are being put on the wall.

These were also being shot to measure any of the outside wall settlement .

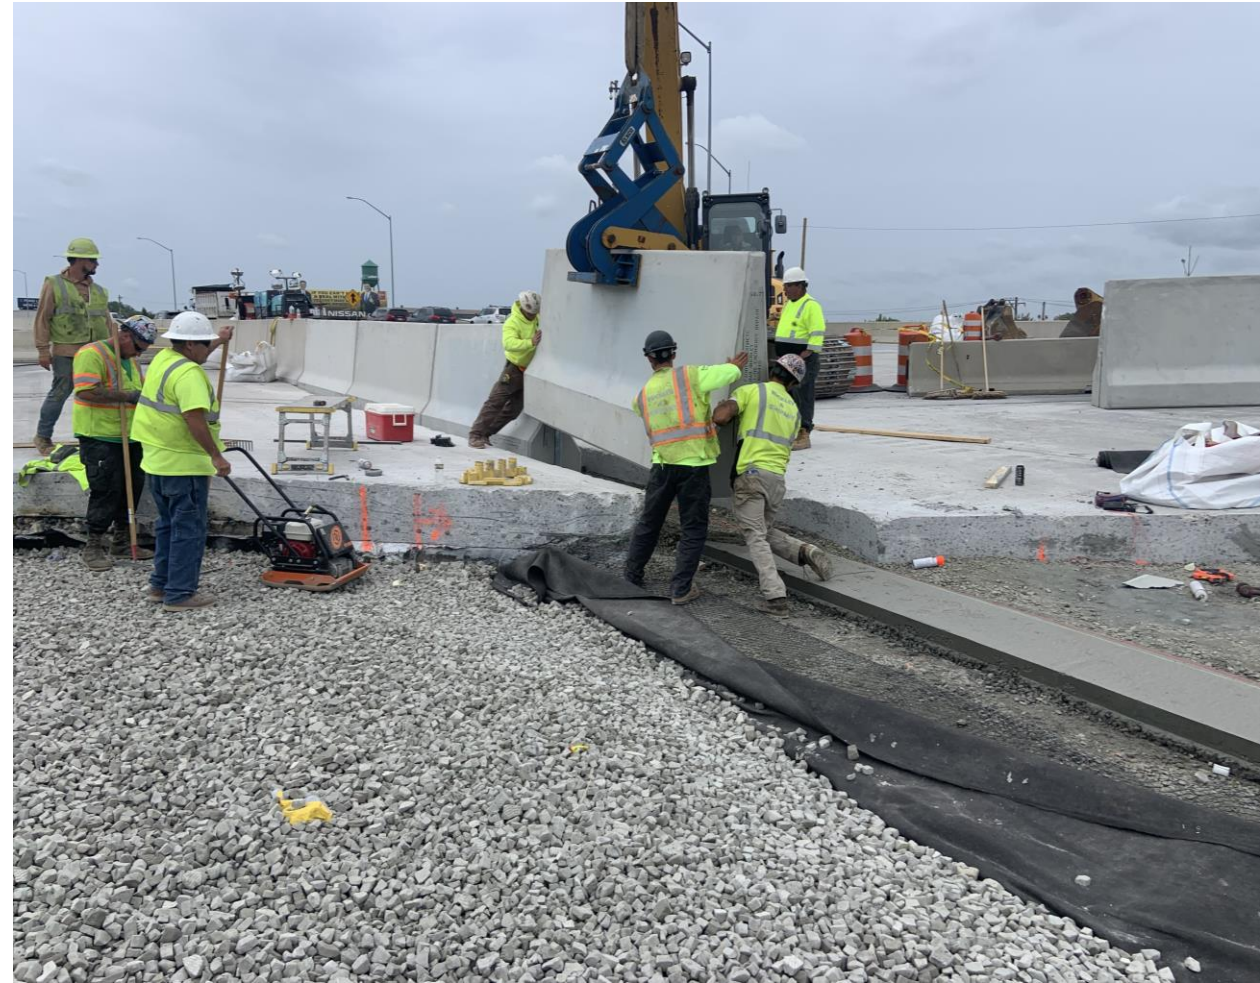
# WEDNESDAY - JUNE 21

Median barrier being installed.

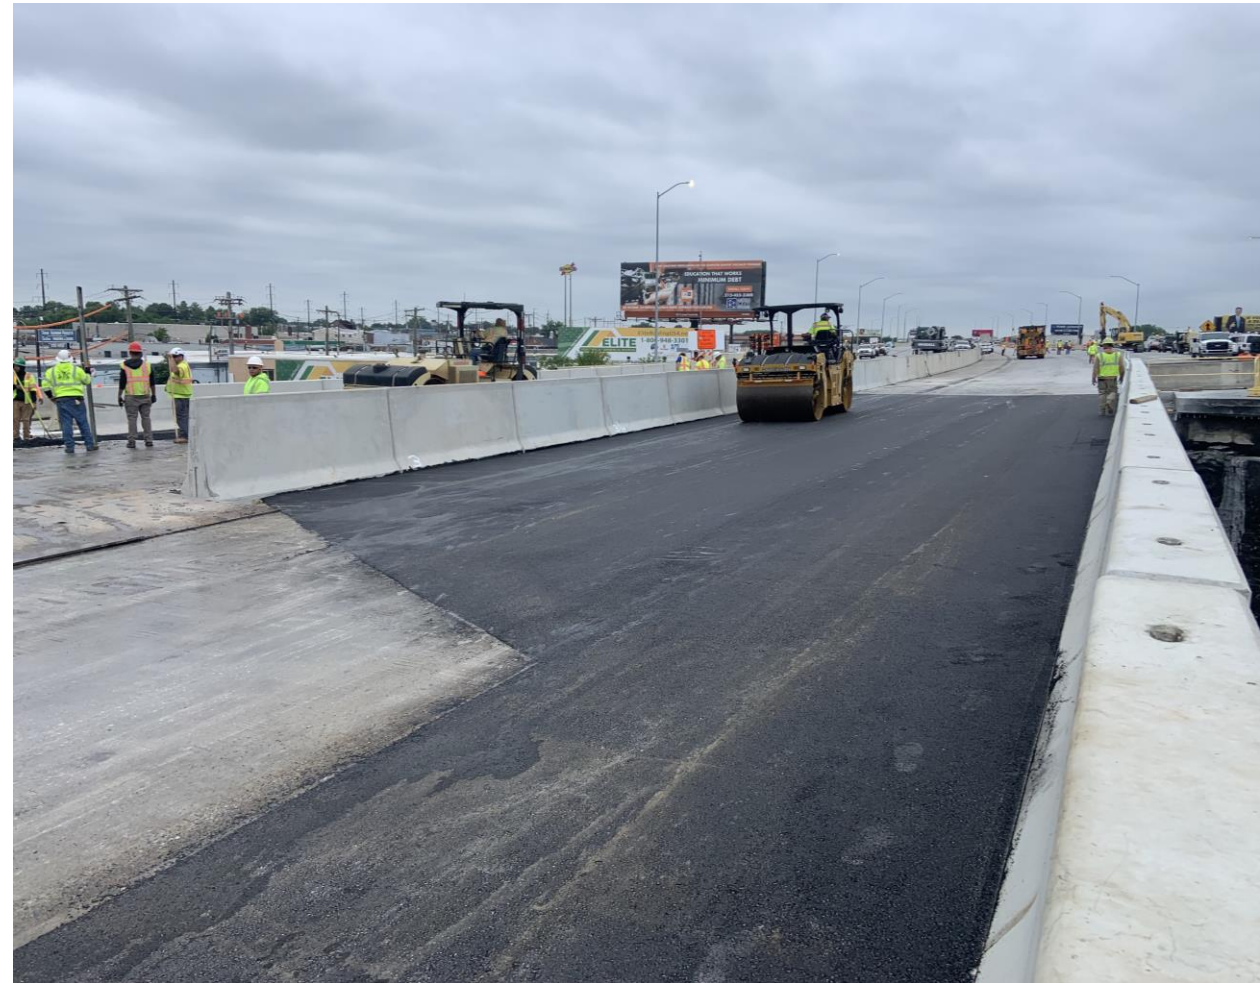
# THURSDAY - JUNE 22

Wearing course paved and rolled.

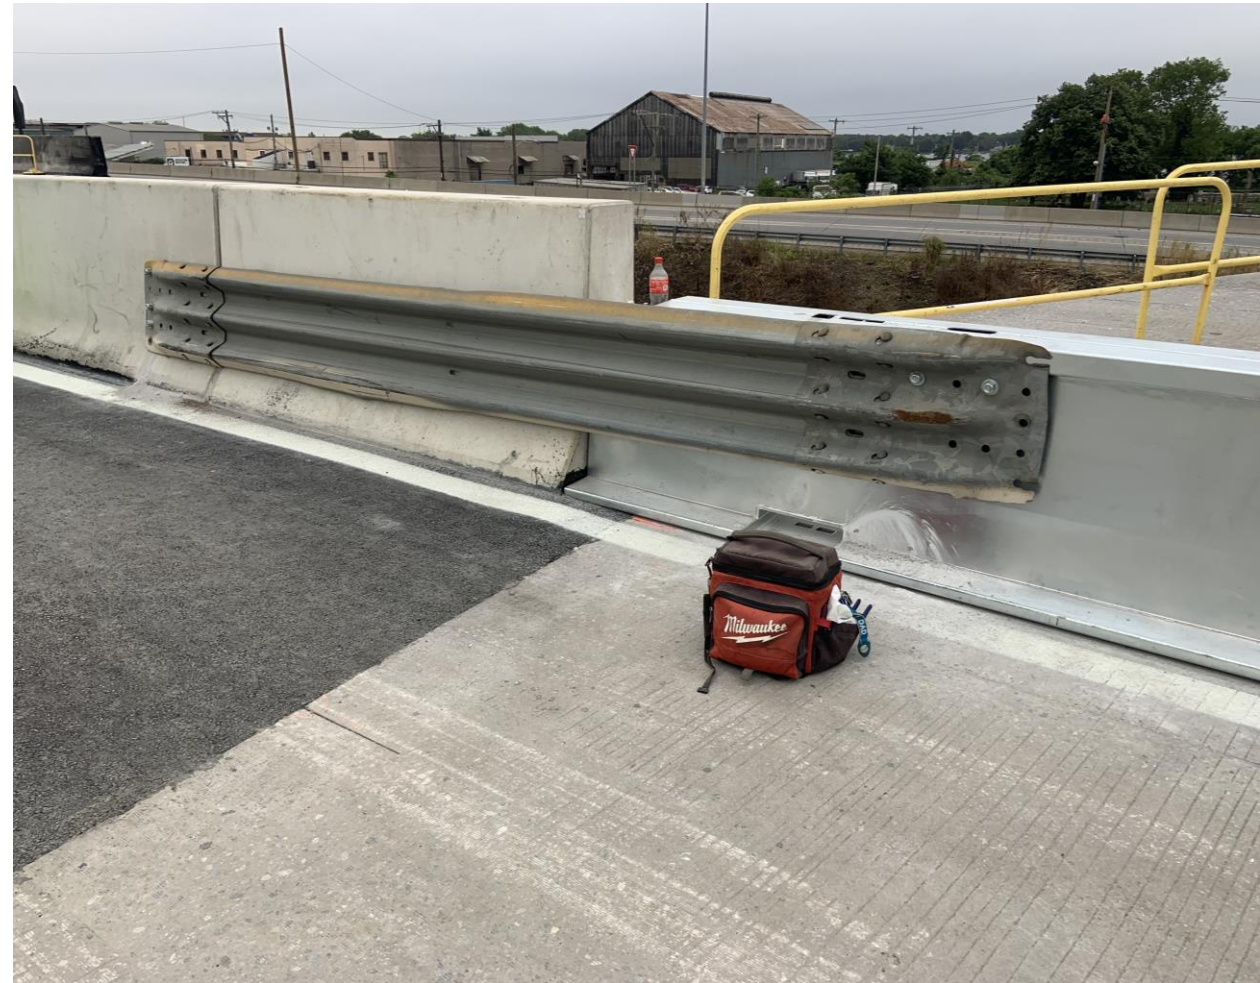
# FRIDAY - JUNE 23

Today is the day! Metal barrier installed and transition pieces installed.
