# REBUILDING I-95

# I-95 TANKER FIRE & BRIDGE COLLAPSE

Philadelphia, PA

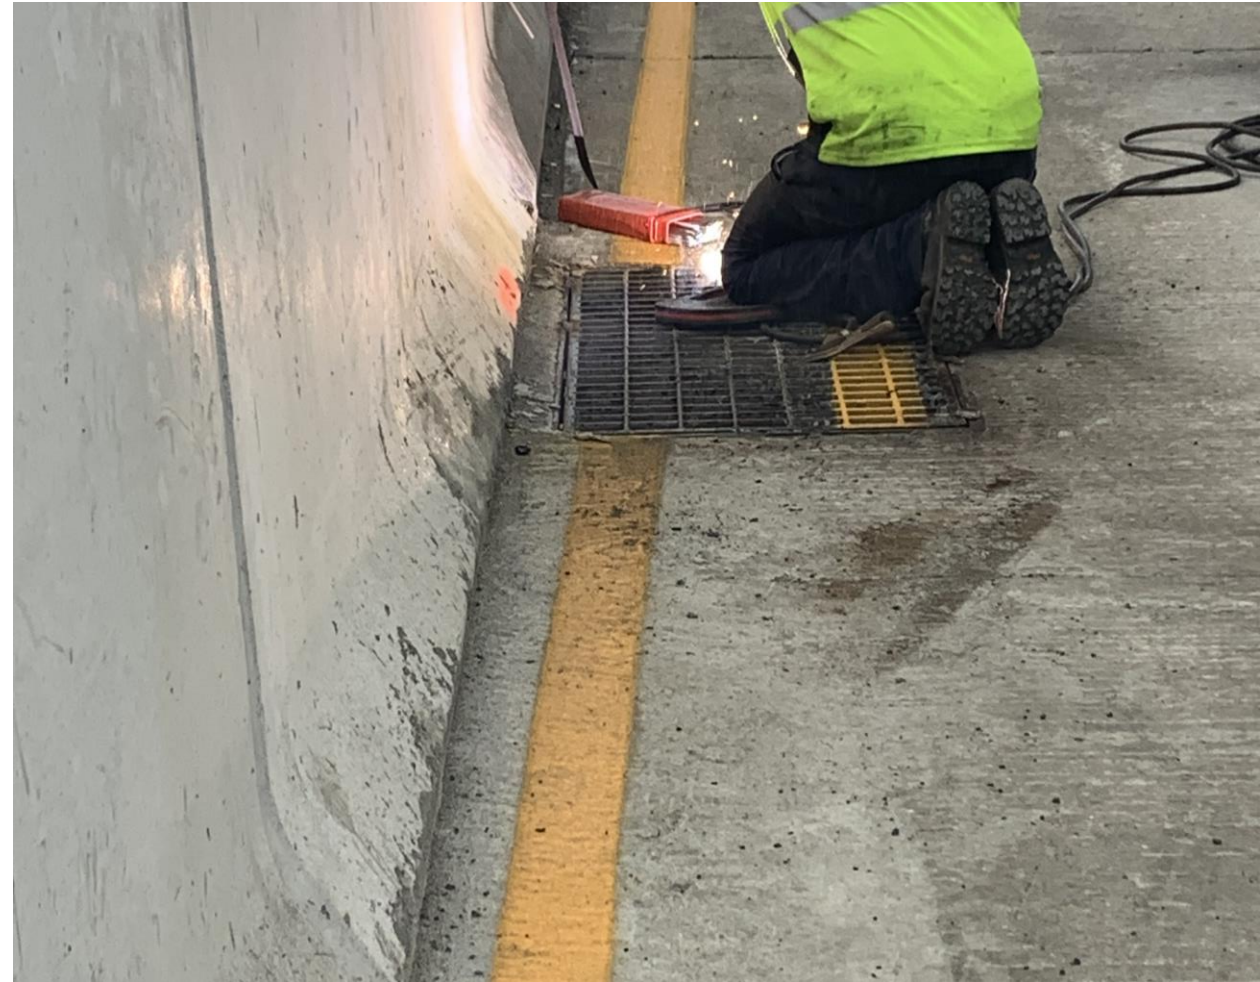
# FRIDAY - JUNE 23

Tacked down the inlet grates, and used a pendulum inside.

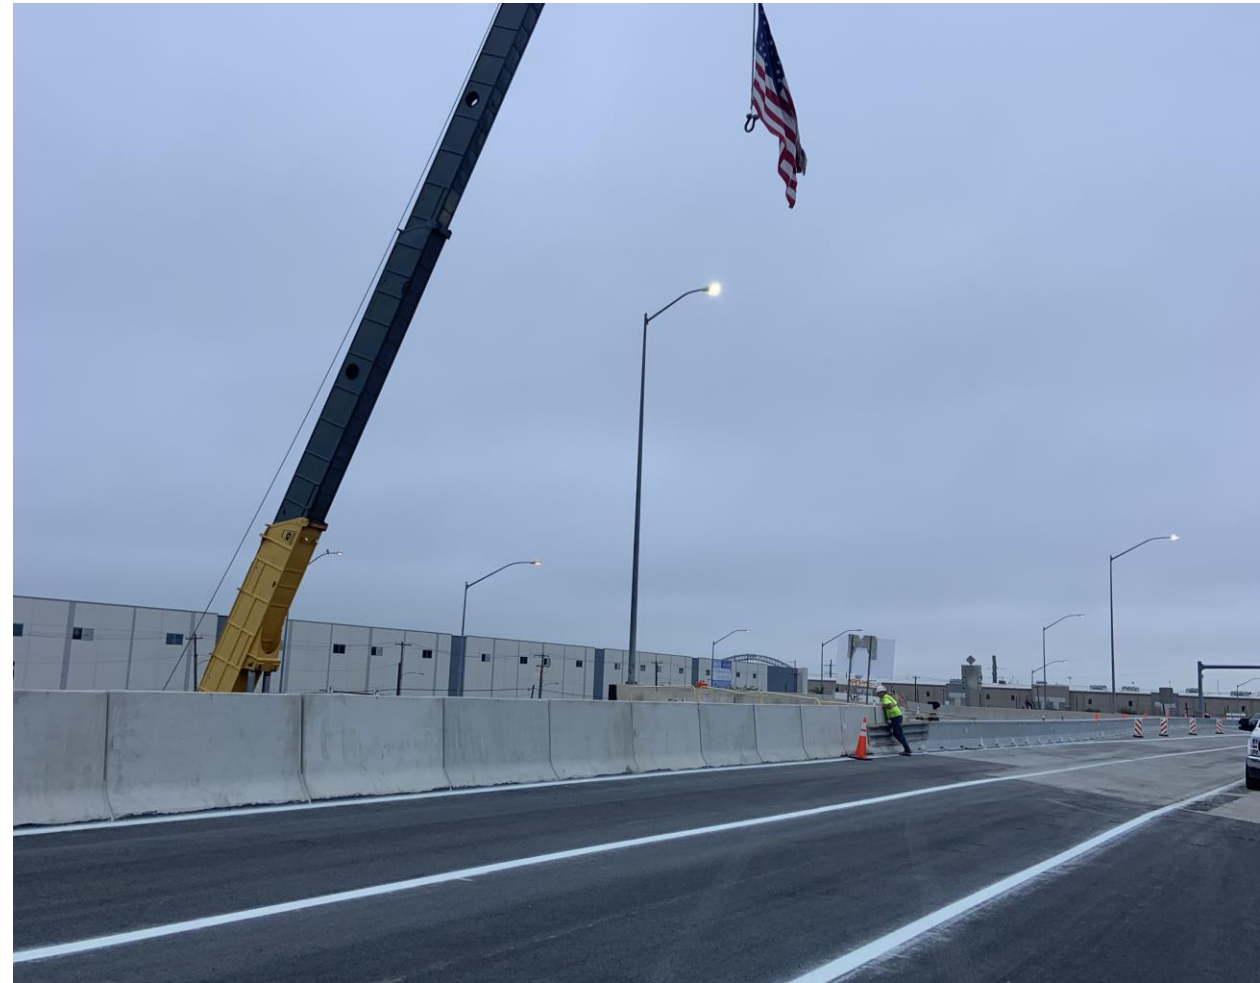
# FRIDAY - JUNE 23

Lines striped.  
Lights back working.  
Flag hoisted.

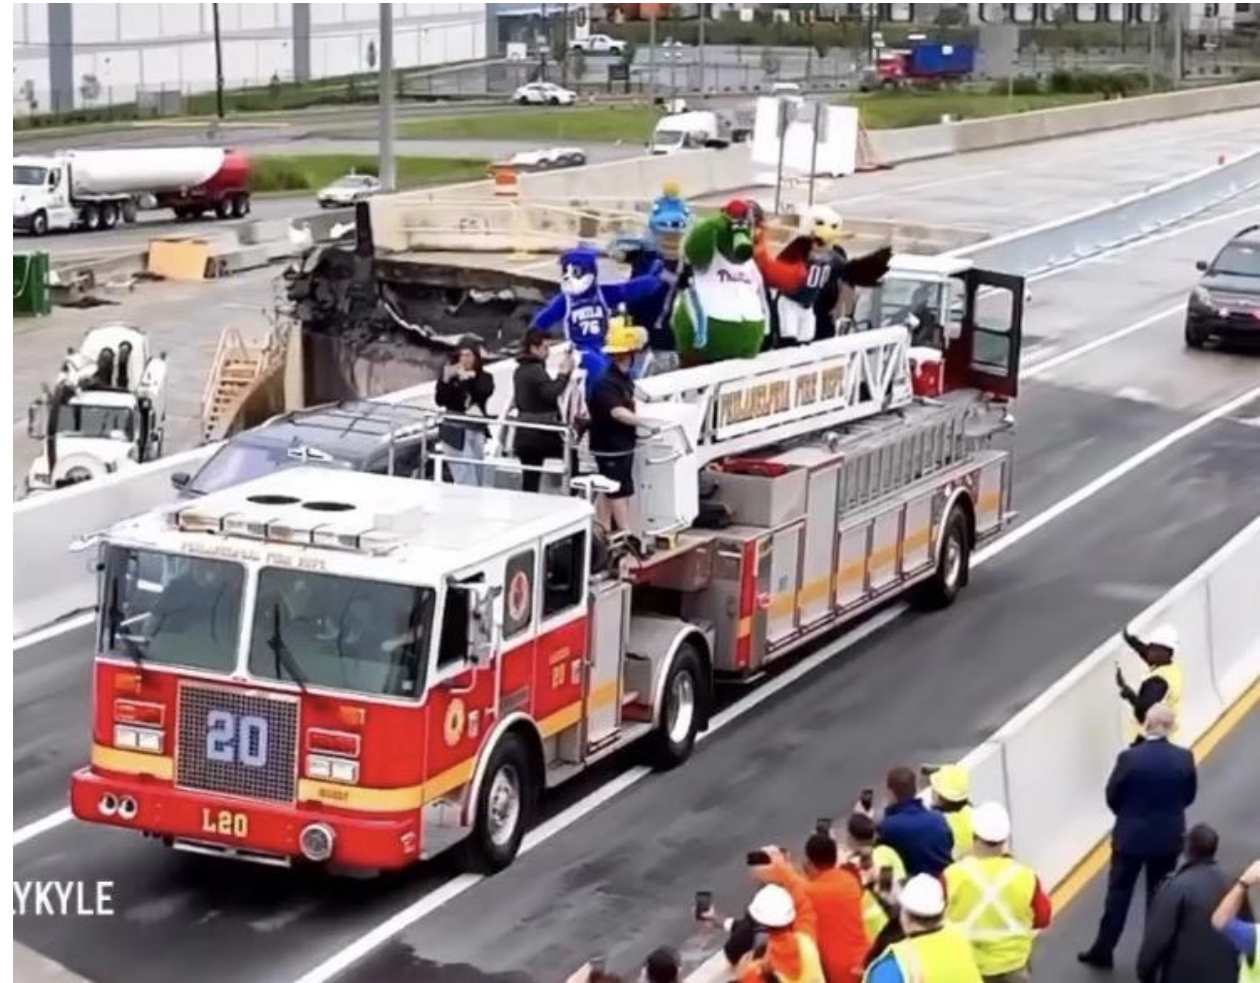
# FRIDAY - JUNE 23

The first vehicles over the temporary road.
